DOCK PYLON EVALUATION REPORT

Comprehensive Material Assessment & Preservation Analysis

CLIENT INFORMATION	
Name	: (Redacted – Sample Document)
Address	: (Redacted – Sample Document)
Email	: (Redacted – Sample Document)
Phone	: (Redacted – Sample Document)
Evaluation Date	06/02/2026
Evaluator	Ed R.

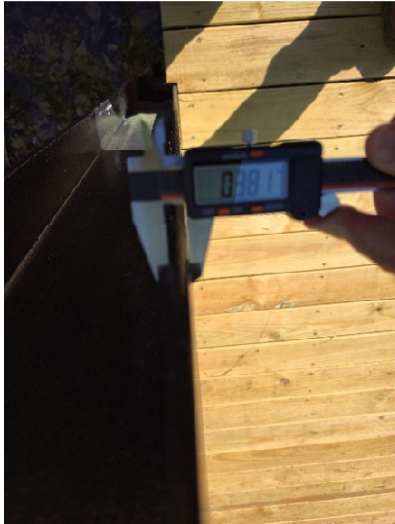
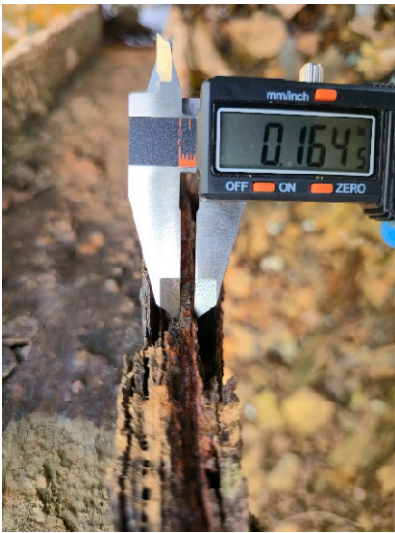
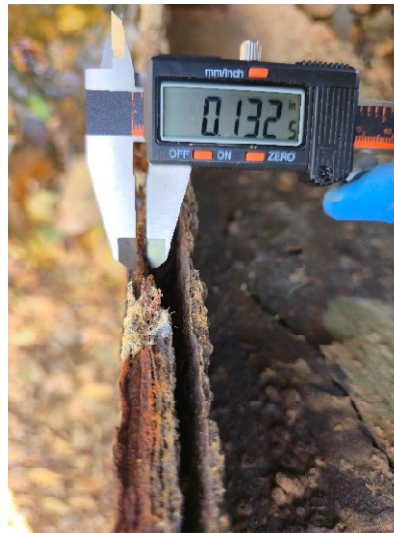
Metal Loss: 62% | Extreme Material Loss (Reconstruction Required)

MEASUREMENT	LEFT FLANGE	RIGHT FLANGE
Original Thickness	.381"	.389"
Neck / Splash Zone	.164"	.132"
Material Loss	62% — Extreme Material Loss (Reconstruction Required)

This pylon exhibits a documented 62% material loss. This represents a conservative baseline metric, as comprehensive mechanical descaling would be required to establish the full extent of the degradation, likely yielding a higher percentage. This component is one of two pylons supporting the main walkway girder. Because the localized material loss is so extensive, standard 24-inch heavy-duty reinforcement plates cannot be utilized, as there is insufficient remaining material on the upper portion of the pylon to securely anchor the hardware. Consequently, remediation via component replacement or reconstruction is recommended. Addressing this asset condition is critical to preventing total material depletion.

RECOMMENDED ACTION	Component reconstruction or replacement required
---------------------------	--

During reconstruction, it is recommended to install a web plate and replace the existing girder connection hardware. Following the completion of the reconstruction process, the entire pylon should receive a minimum of two coats of marine epoxy to encapsulate the component and mitigate subsequent atmospheric or water-line oxidation. Additionally, sacrificial anodes should be installed to provide ongoing galvanic protection for the newly reconstructed components.

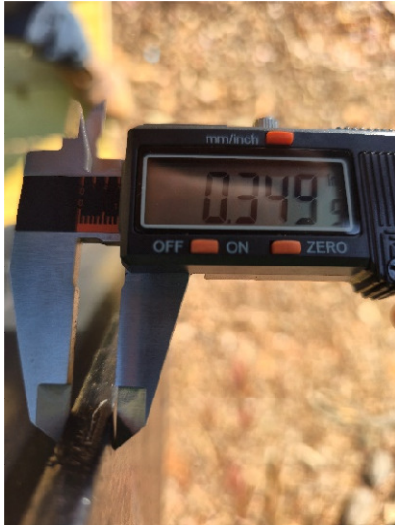
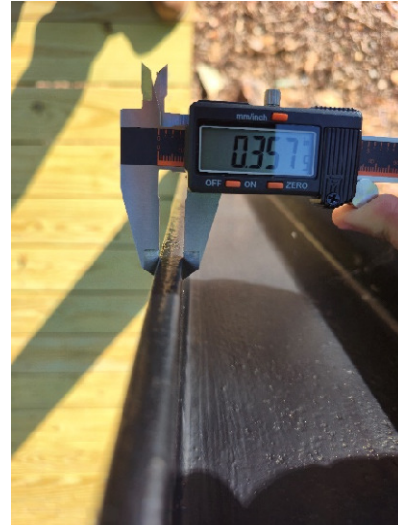
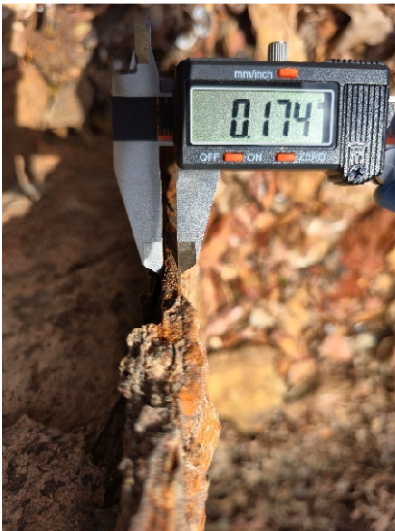
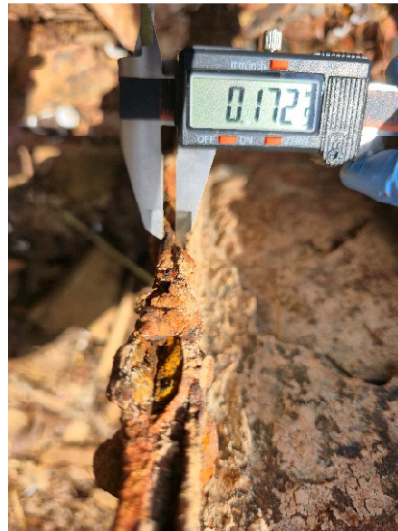
Metal Loss: 51% | Extreme Material Loss (Reconstruction Required)

MEASUREMENT	LEFT FLANGE	RIGHT FLANGE
Original Thickness	.349"	.357"
Neck / Splash Zone	.174"	.172"
Material Loss	51% — Extreme Material Loss (Reconstruction Required)

This pylon exhibits a documented 51% material loss. As this component pairs with the previously detailed pylon supporting the main walkway girder and shares a matching installation timeline, it exhibits a similar degradation pattern. Consequently, identical remediation protocols—including component replacement or reconstruction, hardware updates, web plate installation, marine epoxy encapsulation, and sacrificial anode implementation—are recommended for this asset.

RECOMMENDED ACTION	Component reconstruction or replacement required
---------------------------	--

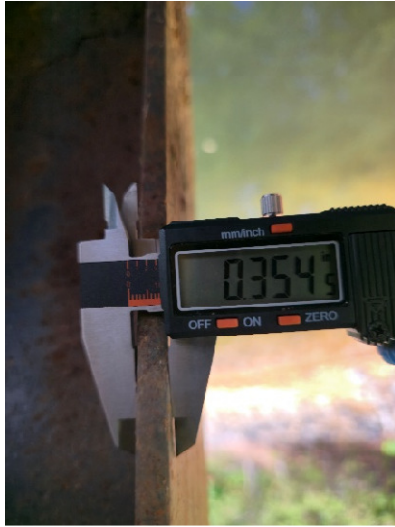
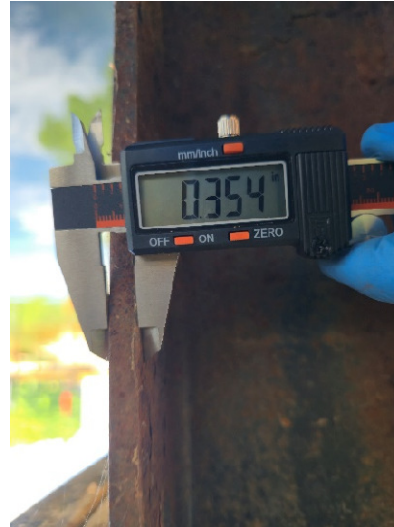
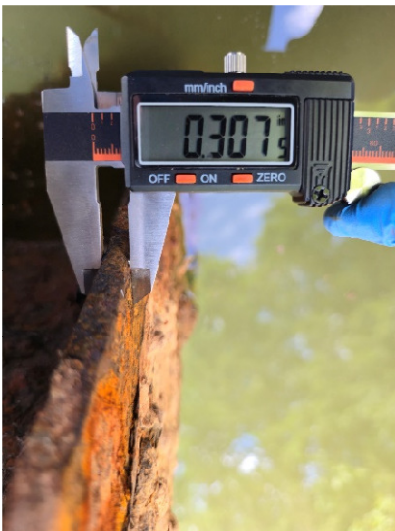
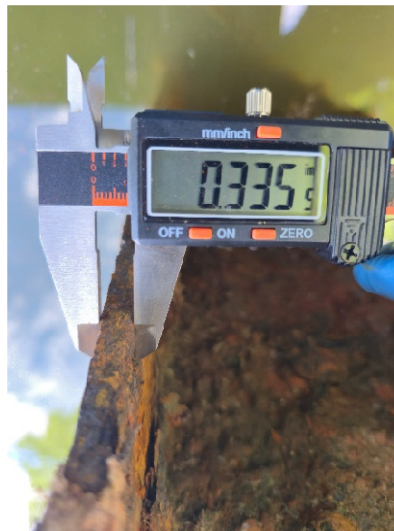
Metal Loss: 9% | Progressed Surface Corrosion (Heavy Scaling/Rust)

MEASUREMENT	LEFT FLANGE	RIGHT FLANGE
Original Thickness	.354"	.354"
Neck / Splash Zone	.307"	.335"
Material Loss	9% — Progressed Surface Corrosion (Heavy Scaling/Rust)

Severe, yet superficial, metal scaling is evident across the entire pylon, extending from the water line to the underside of the dock. While the overall average material loss remains low, localized measurements vary between the two flanges: one flange exhibits a 5% loss, while the opposing flange shows a 13% loss. Although the current average metric is within manageable parameters, it is critical to note that the localized degradation on the heavily affected flange is approaching the threshold of accelerated material thinning.

RECOMMENDED ACTION	Proactive surface remediation & protective coatings
---------------------------	---

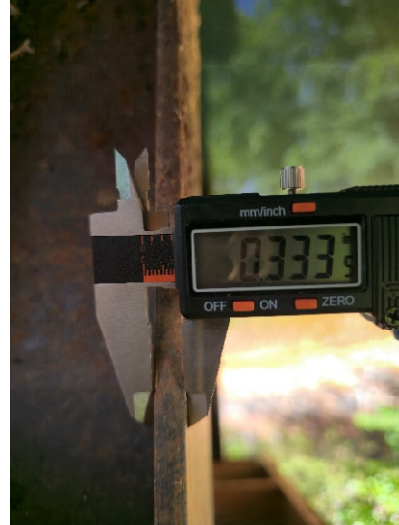
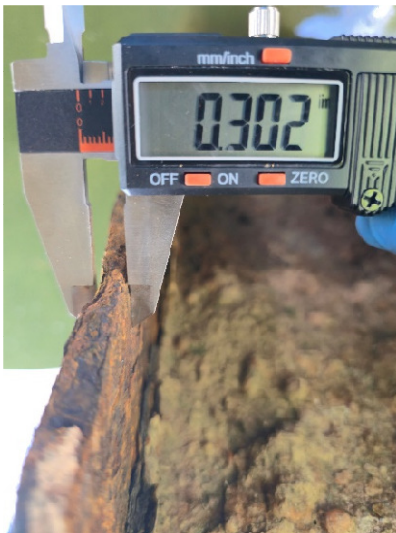
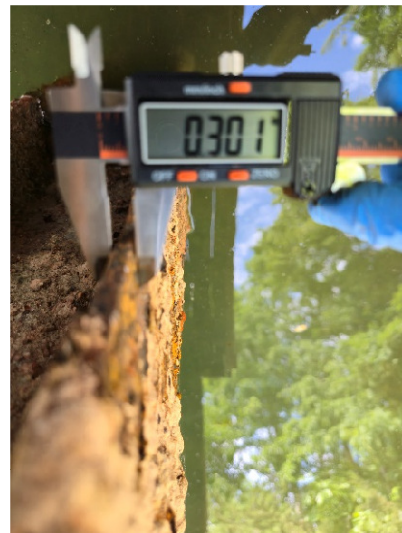
Metal Loss: 12% | Progressed Surface Corrosion (Heavy Scaling/Rust)

MEASUREMENT	LEFT FLANGE	RIGHT FLANGE
Original Thickness	.354"	.333"
Neck / Splash Zone	.302"	.301"
Material Loss	12% — Progressed Surface Corrosion (Heavy Scaling/Rust)

Severe, yet superficial, metal scaling is evident across the entire pylon, extending from the water line to the underside of the dock. While the overall average material loss remains low, localized measurements vary between the two flanges: one flange exhibits a 10% loss, while the opposing flange shows a 15% loss. Although the current average metric is within manageable parameters, it is critical to note that the localized degradation on the heavily affected flange is at the threshold of accelerated material thinning.

RECOMMENDED ACTION	Proactive surface remediation & protective coatings
---------------------------	---

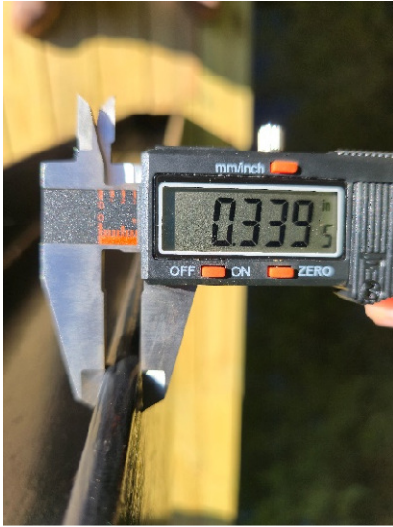
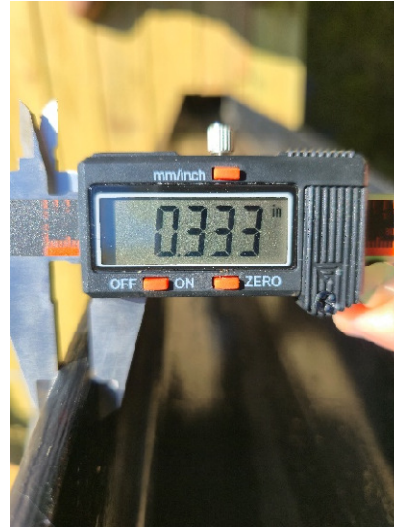
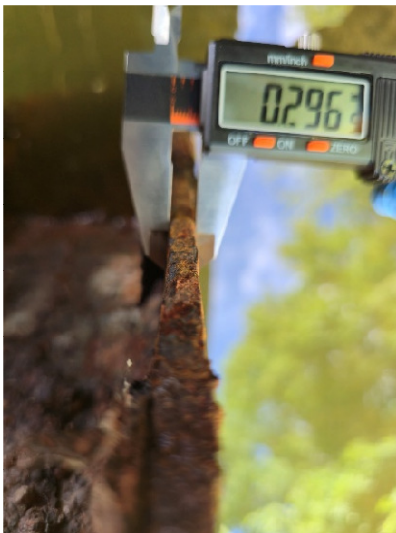
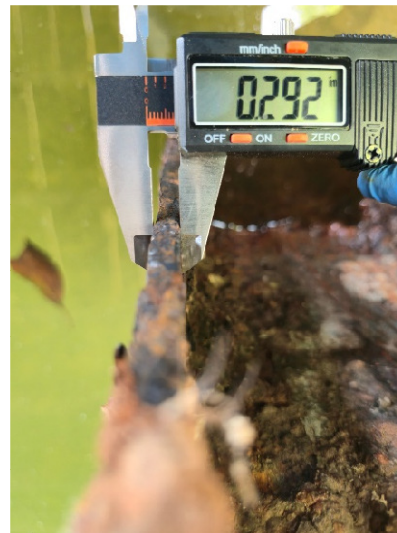
Metal Loss: 13% | Progressed Surface Corrosion (Heavy Scaling/Rust)

MEASUREMENT	LEFT FLANGE	RIGHT FLANGE
Original Thickness	.339"	.333"
Neck / Splash Zone	.296"	.292"
Material Loss	13% — Progressed Surface Corrosion (Heavy Scaling/Rust)

RECOMMENDED ACTION	Proactive surface remediation & protective coatings
---------------------------	---

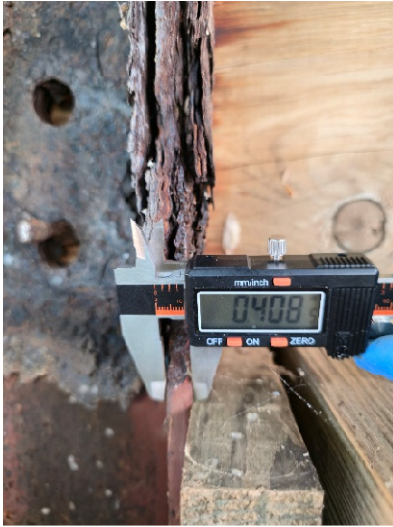
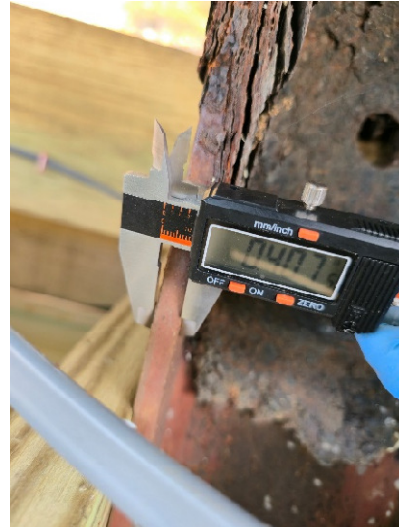
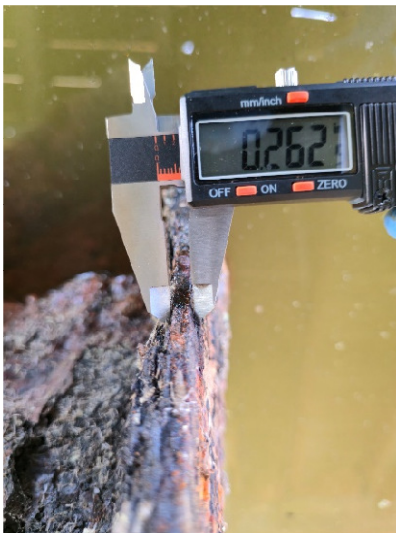
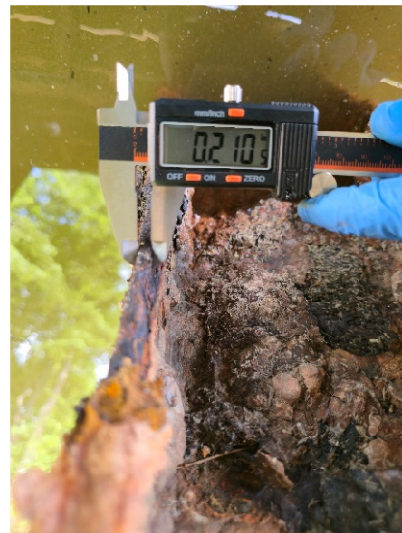
Metal Loss: 42% | Advanced Section Thinning (Plating Needed)

MEASUREMENT	LEFT FLANGE	RIGHT FLANGE
Original Thickness	.408"	.407"
Neck / Splash Zone	.262"	.210"
Material Loss	42% — Advanced Section Thinning (Plating Needed)

This pylon exhibits a documented 42% material loss. This represents a conservative baseline metric, as comprehensive mechanical descaling would be required to establish the full extent of the degradation, likely yielding a higher percentage. This component is one of two pylons supporting one of the main dock girders. Because the localized material loss is so extensive,

standard 24-inch heavy-duty reinforcement plates cannot be utilized, as there is insufficient remaining material on the upper portion of the pylon to securely anchor the hardware. Consequently, remediation via component replacement or reconstruction is recommended. Addressing this asset condition is critical to preventing total material depletion.

In this specific scenario, standard overall material loss percentages do not accurately reflect the severity of the asset condition, as the upper termination zone of the pylon exhibits approximately 90% total material depletion. Immediate remediation via component replacement or reconstruction is recommended to address this localized connection failure point.

RECOMMENDED ACTION	Reinforcement plating needed. Reconstruction recommended
---------------------------	--

During reconstruction, it is recommended to install a web plate and replace the existing girder connection hardware. Following the completion of the reconstruction process, the entire pylon should receive a minimum of two coats of marine epoxy to encapsulate the component and mitigate subsequent atmospheric or water-line oxidation. Additionally, sacrificial anodes should be installed to provide ongoing galvanic protection for the newly reconstructed components.

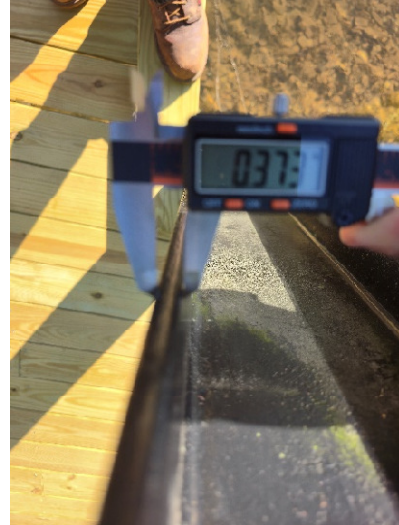
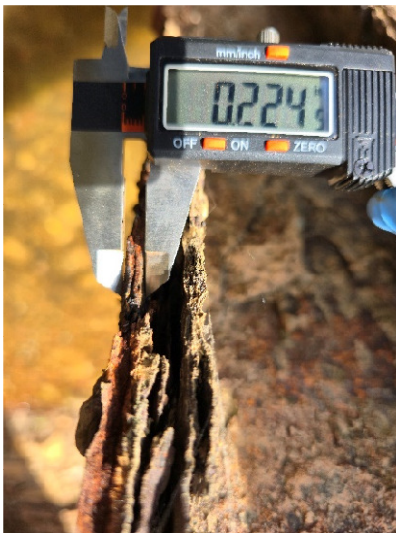
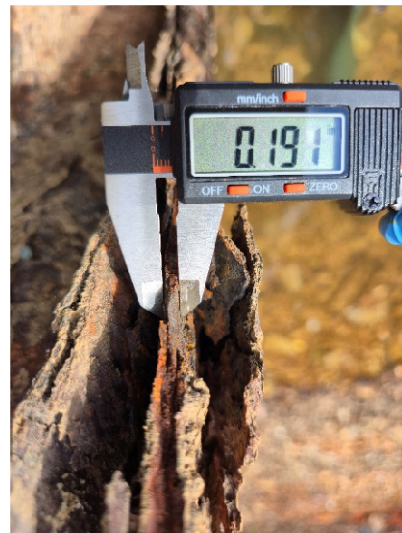
Metal Loss: 45% | Advanced Section Thinning (Plating Needed)

MEASUREMENT	LEFT FLANGE	RIGHT FLANGE
Original Thickness	.384"	.373"
Neck / Splash Zone	.191"	.224"
Material Loss	45% — Advanced Section Thinning (Plating Needed)

This pylon exhibits a documented 45% material loss. Measurement was made without scraping for safety purposes and to minimize any disruption to this fragile asset. This represents a conservative baseline metric, as comprehensive mechanical descaling would be required to establish the full extent of the degradation, likely yielding a higher percentage. This component

is one of two pylons supporting one of the main dock girders. Because the localized material loss is so extensive, standard 24-inch heavy-duty reinforcement plates cannot be utilized, as there is insufficient remaining material on the upper portion of the pylon to securely anchor the hardware. Consequently, remediation via component replacement or reconstruction is recommended. Addressing this asset condition is critical to preventing total material depletion.

Visual documentation of the upper pylon zone reveals a complete absence of flange support infrastructure. The interface relies entirely on two existing fasteners attached to the heavily degraded pylon. Of these two fasteners, one appears entirely encapsulated by corrosion within the girder and beam interface. Physical deformation of the upper fastener, which is visibly bent downward, indicates it is independently supporting the physical connection.

In this specific scenario, standard overall material loss percentages do not accurately reflect the severity of the asset condition, as the upper termination zone of the pylon exhibits 100% total material depletion of the original supporting flange structure. Immediate remediation via component replacement or reconstruction is recommended to address this localized connection failure point.

RECOMMENDED ACTION	Reinforcement plating needed. Reconstruction recommended
---------------------------	--

During reconstruction, it is recommended to install a web plate and replace the existing girder connection hardware. Following the completion of the reconstruction process, the entire pylon should receive a minimum of two coats of marine epoxy to encapsulate the component and mitigate subsequent atmospheric or water-line oxidation. Additionally, sacrificial anodes should be installed to provide ongoing galvanic protection for the newly reconstructed components.

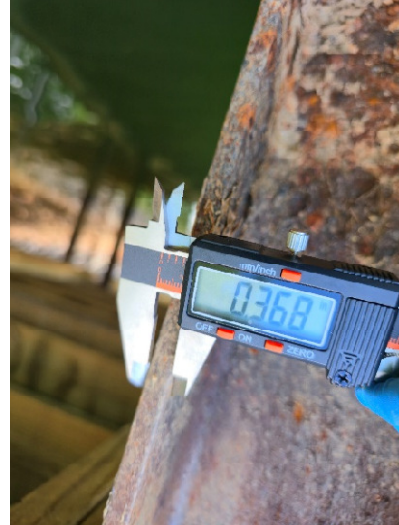
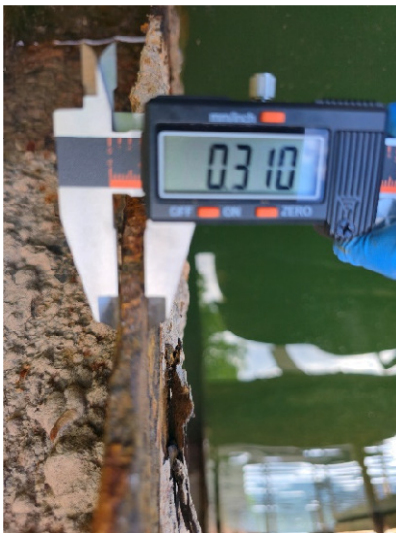
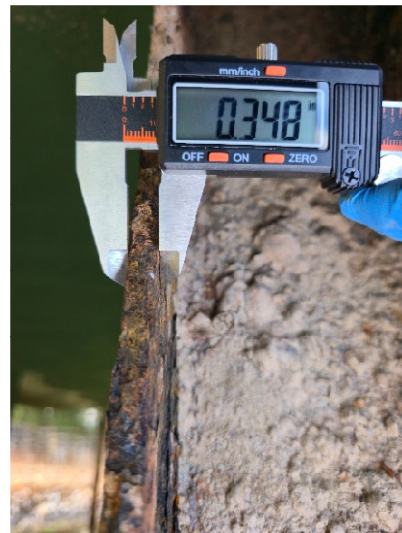
Metal Loss: 8% | Surface Corrosion (Heavy Scaling/Rust)

MEASUREMENT	LEFT FLANGE	RIGHT FLANGE
Original Thickness	.345"	.368"
Neck / Splash Zone	.310"	.348"
Material Loss	8% — Surface Corrosion (Heavy Scaling/Rust)

parameters, it is critical to note that the localized degradation on the heavily affected flange represents twice the material loss of the opposing flange.

RECOMMENDED ACTION	Proactive surface remediation & protective coatings
---------------------------	---

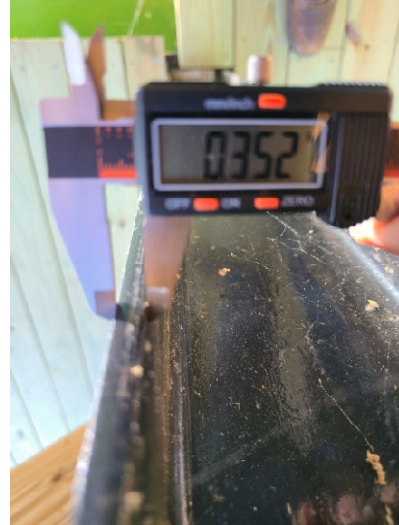
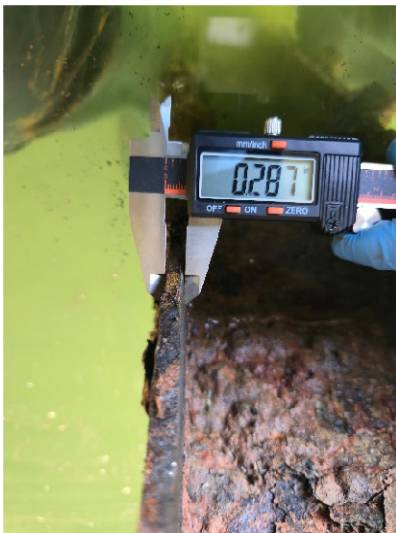
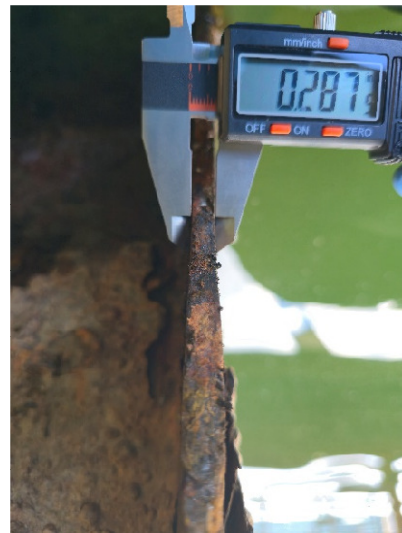
Metal Loss: 16% | Accelerated Section Thinning (Severe Scaling)

MEASUREMENT	LEFT FLANGE	RIGHT FLANGE
Original Thickness	.334"	.352"
Neck / Splash Zone	.287"	.287"
Material Loss	16% — Accelerated Section Thinning

Although localized profile narrowing (necking) is the primary observation, active rust scaling is present across the entire pylon surface, extending continuously from the water line to the underside of the dock structure. Measuring at approximately 16% material loss within the splash zone, this component has progressed beyond baseline environmental weathering.

RECOMMENDED ACTION	Proactive surface remediation & protective coatings
---------------------------	---

Implementation of encapsulation protocols at this stage is recommended to arrest ongoing oxidation and mitigate subsequent material loss that would necessitate the future use of heavy-duty steel reinforcement plates.

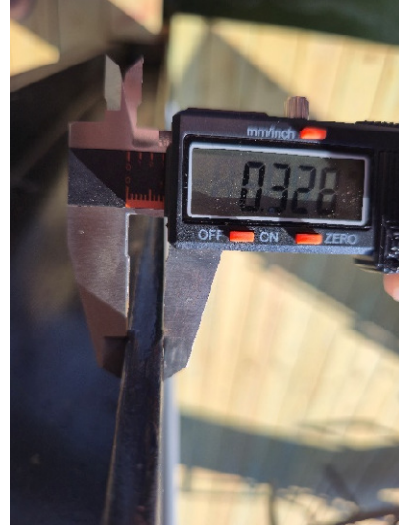
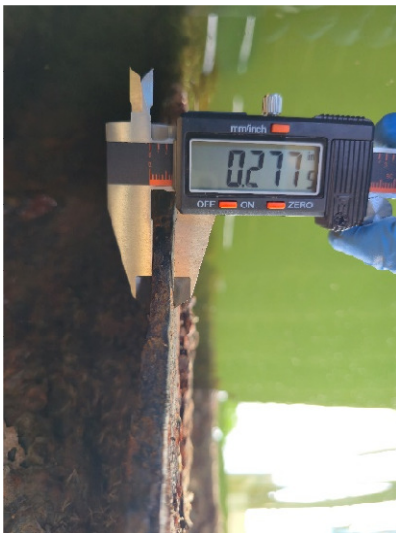
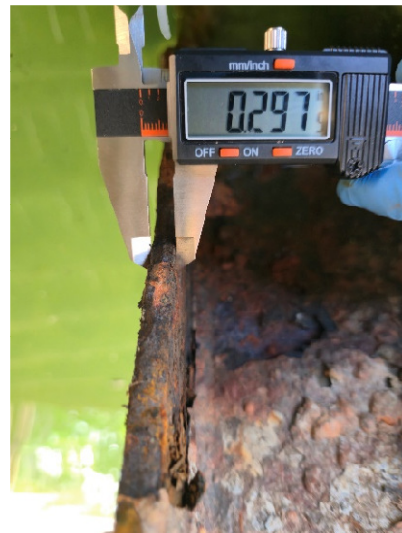
Metal Loss: 15% | Progressed Surface Corrosion (Heavy Scaling/Rust)

MEASUREMENT	LEFT FLANGE	RIGHT FLANGE
Original Thickness	.350"	.328"
Neck / Splash Zone	.277"	.297"
Material Loss	15% — Progressed Surface Corrosion (Heavy Scaling/Rust)

RECOMMENDED ACTION	Proactive surface remediation & protective coatings
---------------------------	---

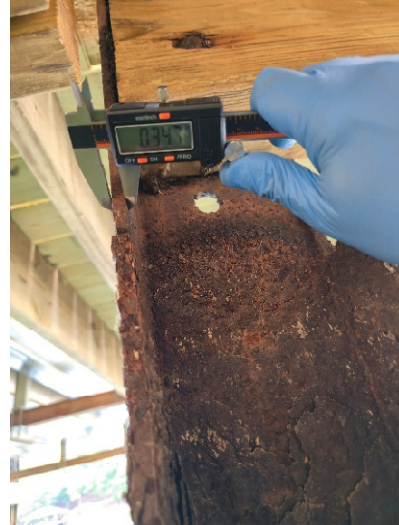
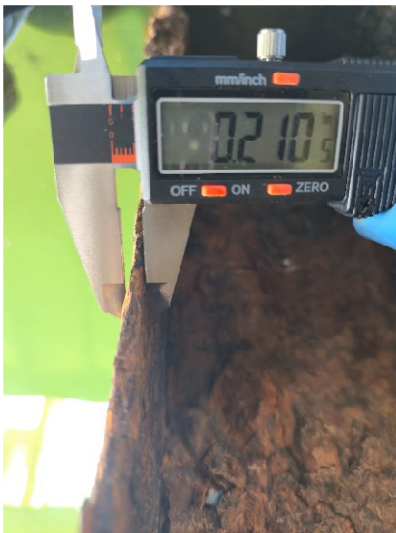
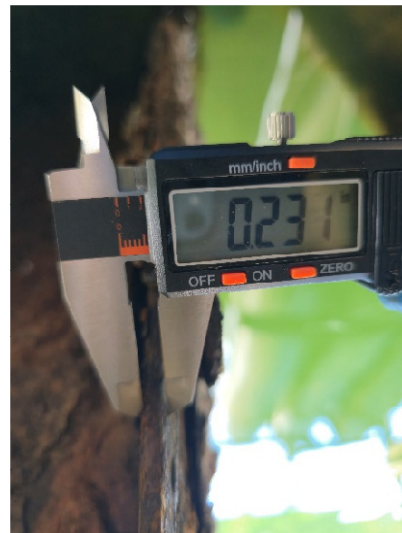
Metal Loss: 36% | Advanced Section Thinning (Plating Needed)

MEASUREMENT	LEFT FLANGE	RIGHT FLANGE
Original Thickness	.342"	.347"
Neck / Splash Zone	.210"	.231"
Material Loss	36% — Advanced Section Thinning (Plating Needed)

This pylon measures at 36% metal loss, indicating advanced section thinning. Based on these measurements, we recommend the installation of heavy-duty reinforcement plating. Mechanical descaling is required to fully determine the exact condition of the underlying steel.

RECOMMENDED ACTION	Reinforcement plating — reconstruction recommended
---------------------------	--

At this tier of material degradation, the application of reinforcement plates is recommended as a standard preventative measure.

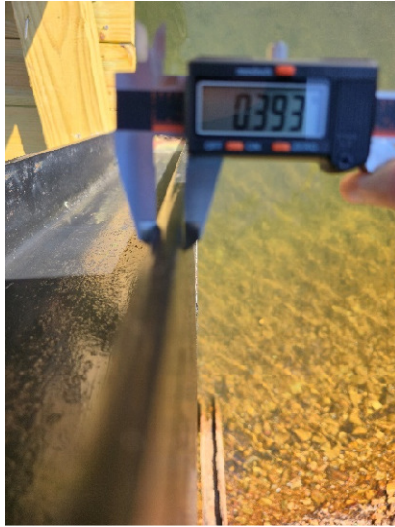
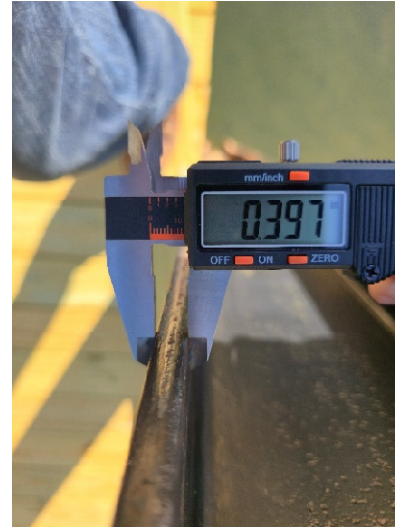
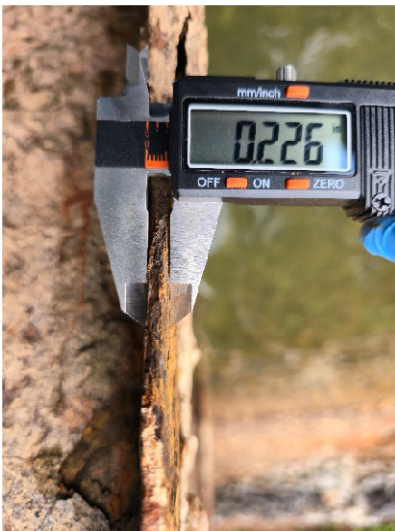
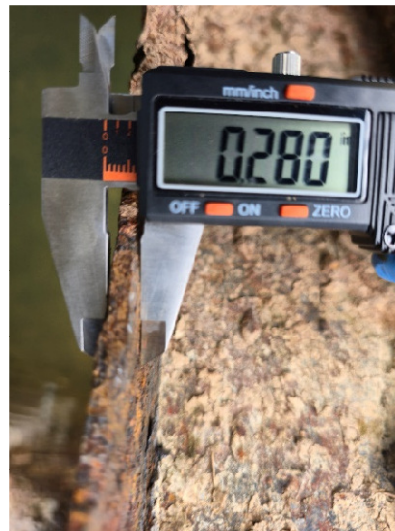
Metal Loss: 36% | Advanced Section Thinning (Plating Needed)

MEASUREMENT	LEFT FLANGE	RIGHT FLANGE
Original Thickness	.393"	.397"
Neck / Splash Zone	.226"	.280"
Material Loss	36% — Advanced Section Thinning (Plating Needed)

This pylon exhibits a documented 36% material loss. Measurement was made without scraping for safety purposes and to minimize any disruption to this fragile asset. This represents a conservative baseline metric, as comprehensive mechanical descaling would be required to establish the full extent of the degradation, likely yielding a higher percentage. This component

is a primary support for one of the main dock girders. Because the localized material loss is so extensive, standard 24-inch heavy-duty reinforcement plates cannot be utilized, as there is insufficient remaining material on the upper portion of the pylon to securely anchor the hardware. Consequently, remediation via component replacement or reconstruction is recommended. Addressing this asset condition is critical to preventing total material depletion.

Visual documentation of the upper pylon zone reveals a complete absence of flange support infrastructure. The interface relies entirely on two existing fasteners attached to the heavily degraded pylon. Of these two fasteners, one appears entirely encapsulated by corrosion within the girder and beam interface, this leaves the single upper fastener to independently support the physical connection.

In this specific scenario, standard overall material loss percentages do not accurately reflect the severity of the asset condition, as the upper termination zone of the pylon exhibits 100% total material depletion of the original supporting flange structure. Immediate remediation via component replacement or reconstruction is recommended to address this localized connection failure point.

RECOMMENDED ACTION	Reinforcement plating — reconstruction recommended
---------------------------	--

During reconstruction, it is recommended to install a web plate and replace the existing girder connection hardware. Following the completion of the reconstruction process, the entire pylon should receive a minimum of two coats of marine epoxy to encapsulate the component and mitigate subsequent atmospheric or water-line oxidation. Additionally, sacrificial anodes should be installed to provide ongoing galvanic protection for the newly reconstructed components.

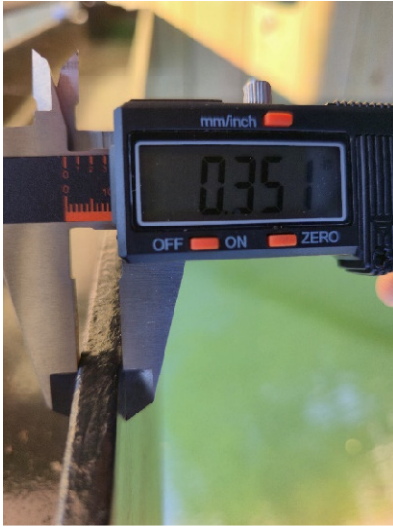
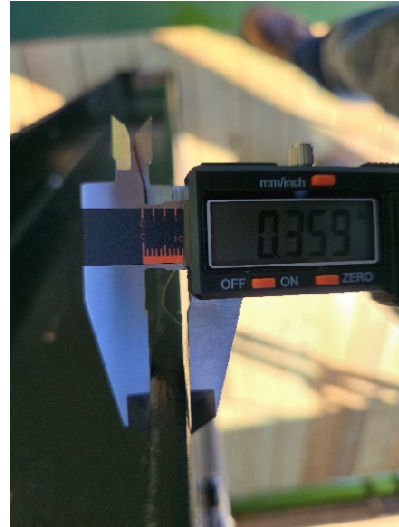
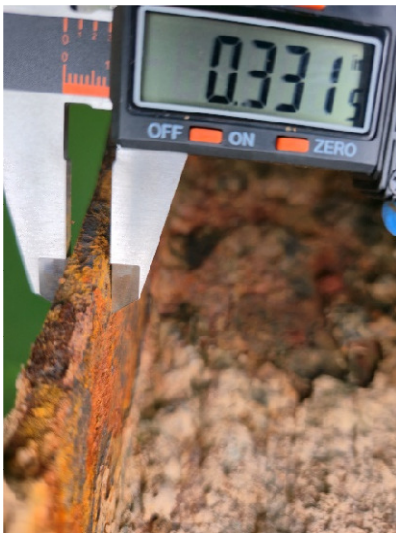
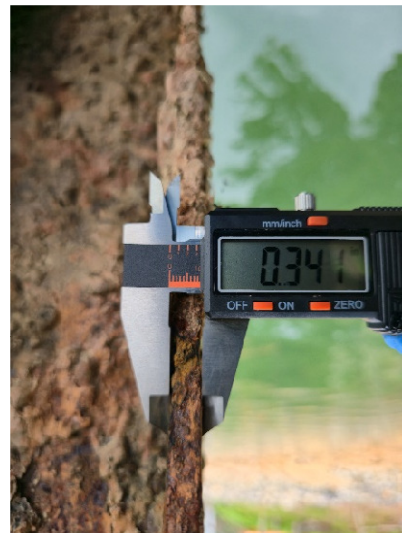
Metal Loss: 5% | Surface Corrosion (Heavy Scaling/Rust)

MEASUREMENT	LEFT FLANGE	RIGHT FLANGE
Original Thickness	.351"	.359"
Neck / Splash Zone	.331"	.341"
Material Loss	5% — Surface Corrosion (Heavy Scaling/Rust)

Although the surface scaling appears heavy, measurements confirm metal loss is minimal. Active rust scaling is present across the entire pylon surface, extending continuously from the water line to the underside of the dock structure. Because this component serves as a direct foundational path for an active, multi-level upper deck assembly, maintaining its original steel thickness profile is a high priority. Consequently, proactive surface remediation and protective coatings are recommended at this stage to preserve the material profile and mitigate long-term oxidation under these operational conditions.

RECOMMENDED ACTION	Proactive surface remediation & protective coatings
---------------------------	---

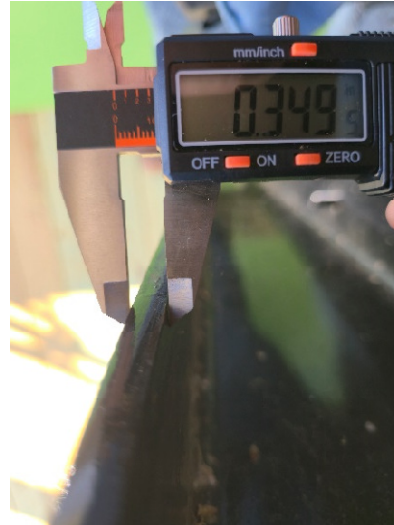
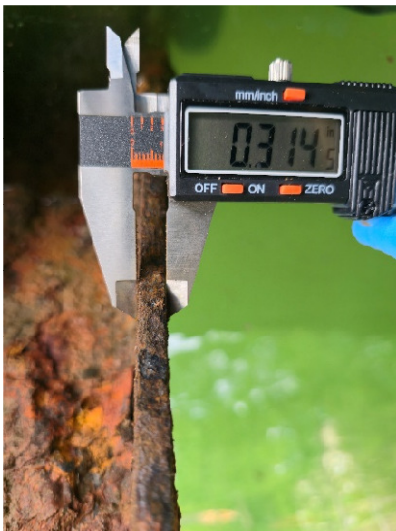
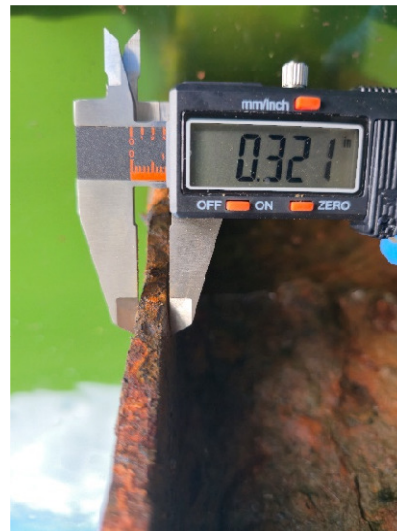
Metal Loss: 7% | Surface Corrosion (Heavy Scaling/Rust)

MEASUREMENT	LEFT FLANGE	RIGHT FLANGE
Original Thickness	.336"	.349"
Neck / Splash Zone	.314"	.321"
Material Loss	7% — Surface Corrosion (Heavy Scaling/Rust)

Although the surface scaling appears heavy, measurements confirm metal loss is minimal. Active rust scaling is present across the entire pylon surface, extending continuously from the water line to the underside of the dock structure. Because this component serves as a direct foundational path for an active, multi-level upper deck assembly, maintaining its original steel thickness profile is a high priority. Consequently, proactive surface remediation and protective coatings are recommended at this stage to preserve the material profile and mitigate long-term oxidation under these operational conditions.

RECOMMENDED ACTION	Proactive surface remediation & protective coatings
---------------------------	---

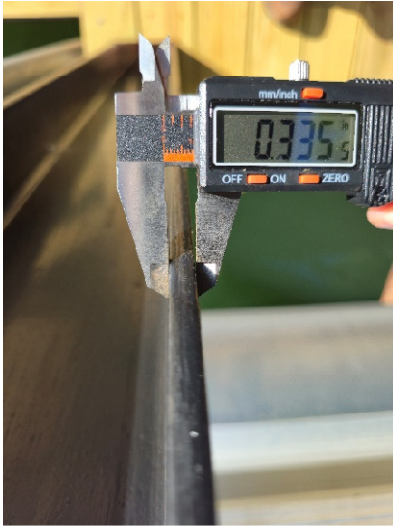
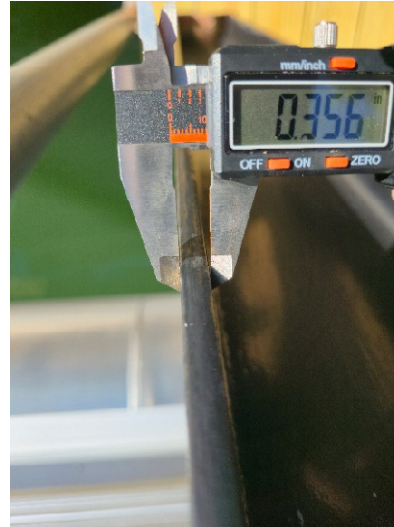
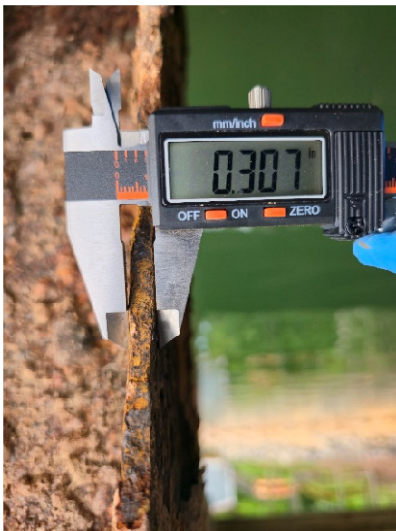
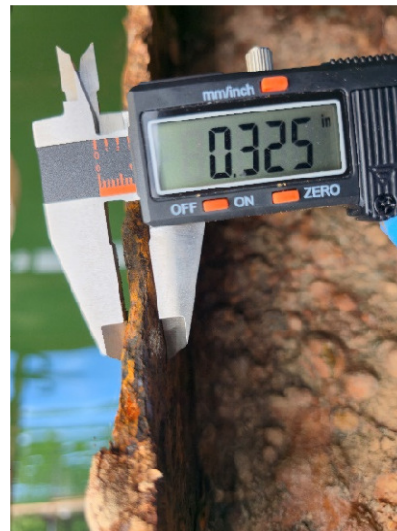
Metal Loss: 9% | Surface Corrosion (Heavy Scaling/Rust)

MEASUREMENT	LEFT FLANGE	RIGHT FLANGE
Original Thickness	.335"	.356"
Neck / Splash Zone	.307"	.325"
Material Loss	9% — Surface Corrosion (Heavy Scaling/Rust)

Although the surface scaling appears heavy, measurements confirm that overall material loss remains minimal. Active rust scaling is present across the entire pylon surface, extending continuously from the water line to the underside of the dock structure. Because this component serves as a direct foundational path for an active, multi-level upper deck assembly, maintaining its original steel thickness profile is a high priority. Consequently, proactive surface remediation and protective coatings are recommended at this stage to preserve the material profile and mitigate long-term oxidation under these operational conditions. This component also supports one of the two guide poles for the floating dock. The guide pole exhibits surface oxidation; it is recommended to mechanically descale this hardware and apply a marine epoxy coating as a preventative maintenance measure.

RECOMMENDED ACTION	Proactive surface remediation & protective coatings
---------------------------	---

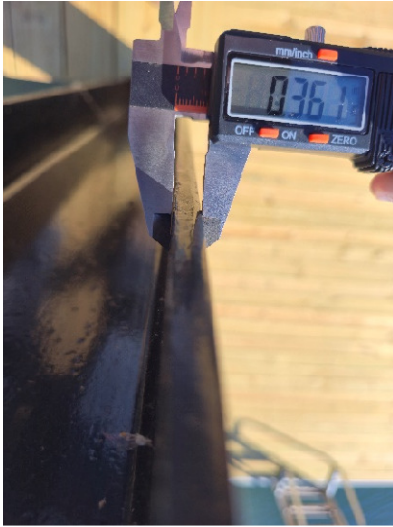
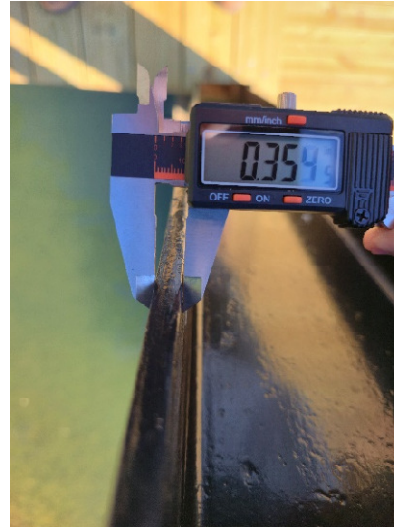
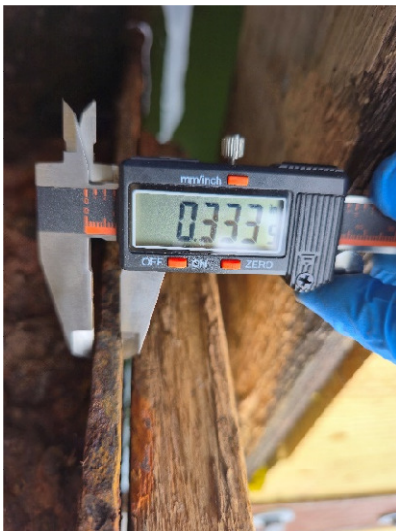
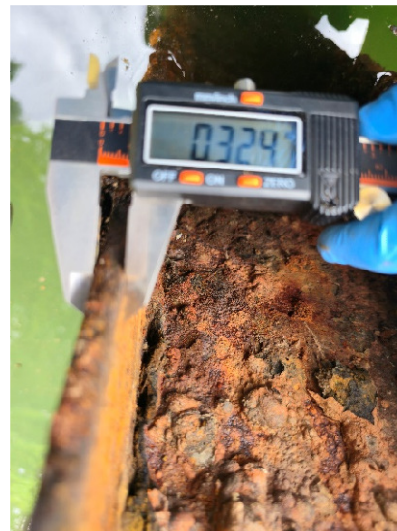
Metal Loss: 8% | Surface Corrosion (Heavy Scaling/Rust)

MEASUREMENT	LEFT FLANGE	RIGHT FLANGE
Original Thickness	.361"	.354"
Neck / Splash Zone	.333"	.324"
Material Loss	8% — Surface Corrosion (Heavy Scaling/Rust)

Although the surface scaling appears heavy, measurements confirm that overall material loss remains minimal. Active rust scaling is present across the entire pylon surface, extending continuously from the water line to the underside of the dock structure. This component supports one of the two guide poles for the floating dock. The guide pole exhibits surface oxidation; it is recommended to mechanically descale this hardware and apply a marine epoxy coating as a preventative maintenance measure.

Additionally, a wooden board is currently mounted lengthwise along the exterior of this pylon, seemingly installed to mitigate impact from the floating dock assembly during wave action. The timber board creates a moisture trap accelerating localized oxidation. Permanent removal of the timber board is recommended prior to epoxy encapsulation to preserve the underlying steel profile.

RECOMMENDED ACTION	Proactive surface remediation & protective coatings — remove timber board
---------------------------	---

To maintain impact mitigation without creating a destructive moisture trap against the steel, alternative non-porous materials or standalone marine bumper options that do not bond directly to the pylon surface should be explored to ensure long-term material stability.

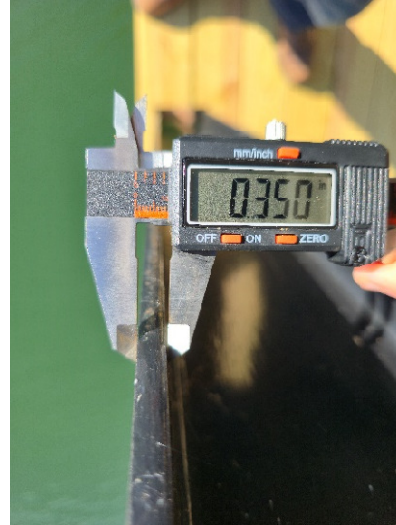
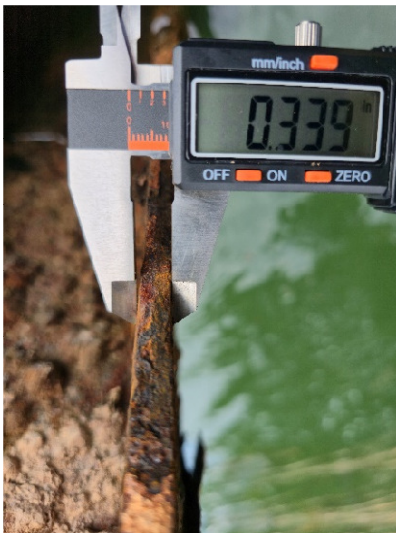
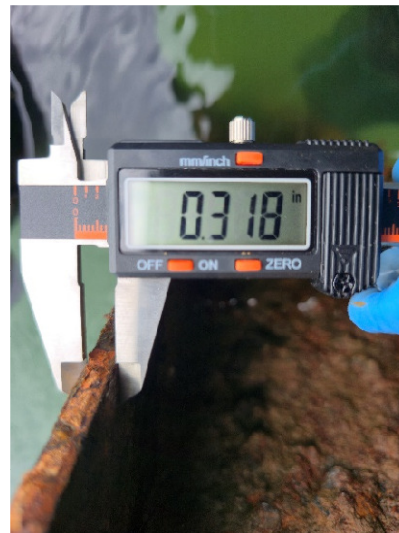
Metal Loss: 9% | Surface Corrosion (Heavy Scaling/Rust)

MEASUREMENT	LEFT FLANGE	RIGHT FLANGE
Original Thickness	.369"	.350"
Neck / Splash Zone	.339"	.318"
Material Loss	9% — Surface Corrosion (Heavy Scaling/Rust)

Although the surface scaling appears heavy, measurements confirm that overall material loss remains minimal. Active rust scaling is present across the entire pylon surface, extending continuously from the water line to the underside of the dock structure. Because this component serves as a direct foundational path for an active, multi-level upper deck assembly, maintaining its original steel thickness profile is a high priority. Consequently, proactive surface remediation and protective coatings are recommended at this stage to preserve the material profile and mitigate long-term oxidation under these operational conditions.

RECOMMENDED ACTION	Proactive surface remediation & protective coatings
---------------------------	---

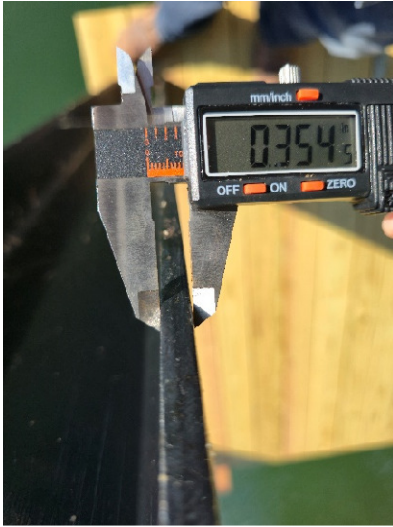
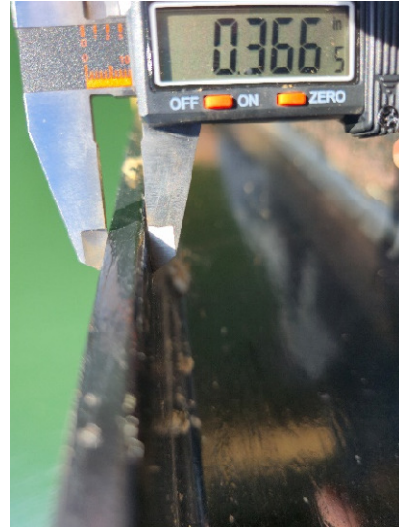
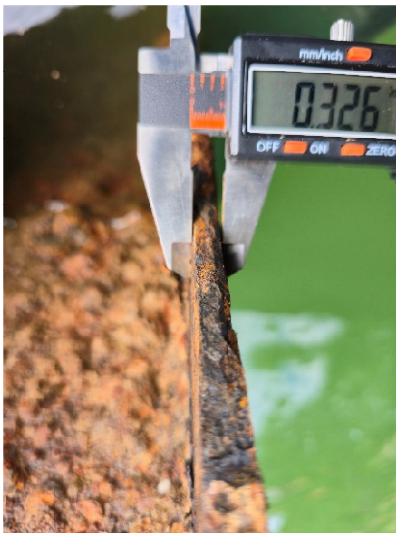
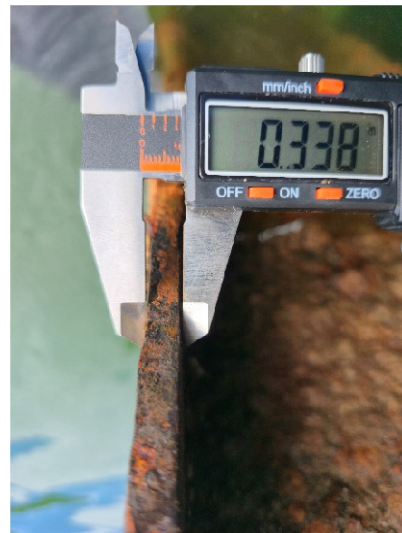
Metal Loss: 8% | Surface Corrosion (Heavy Scaling/Rust)

MEASUREMENT	LEFT FLANGE	RIGHT FLANGE
Original Thickness	.354"	.366"
Neck / Splash Zone	.326"	.338"
Material Loss	8% — Surface Corrosion (Heavy Scaling/Rust)

Although the surface scaling appears heavy, measurements confirm that overall material loss remains minimal. Active rust scaling is present across the entire pylon surface, extending continuously from the water line to the underside of the dock structure. Because this component serves as a direct foundational path for an active, multi-level upper deck assembly, maintaining its original steel thickness profile is a high priority. Consequently, proactive surface remediation and protective coatings are recommended at this stage to preserve the material profile and mitigate long-term oxidation under these operational conditions.

RECOMMENDED ACTION	Proactive surface remediation & protective coatings
---------------------------	---

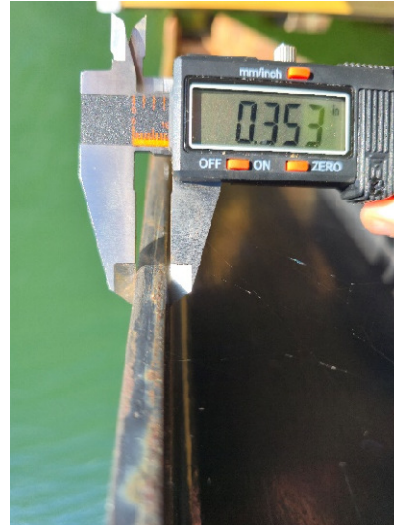
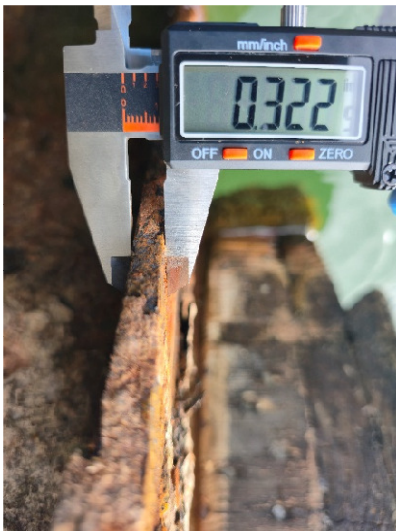
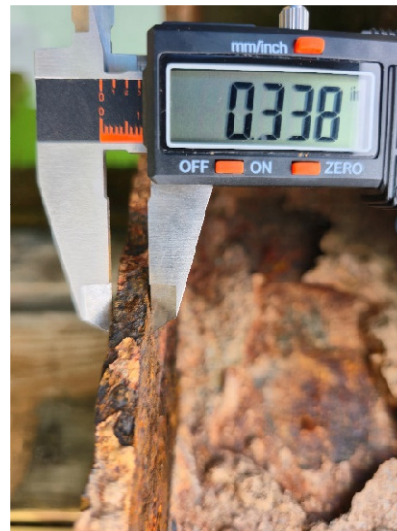
Metal Loss: 8% | Surface Corrosion (Heavy Scaling/Rust)

MEASUREMENT	LEFT FLANGE	RIGHT FLANGE
Original Thickness	.362"	.353"
Neck / Splash Zone	.322"	.338"
Material Loss	8% — Surface Corrosion (Heavy Scaling/Rust)

Although the surface scaling appears heavy, measurements confirm that overall material loss remains minimal, with active rust scaling limited primarily to the necking zone on the pylon. Localized measurements vary between the two flanges: one flange exhibits a 4% loss, while the opposing flange shows an 11% loss. Although the current average metric is within manageable parameters, the localized degradation on the heavily affected flange represents over twice the material loss of the opposing flange.

Because this component serves as a direct foundational path for an active, multi-level upper deck assembly, maintaining its original steel thickness profile is a high priority. Consequently, proactive surface remediation and protective coatings are recommended at this stage to preserve the material profile and mitigate long-term oxidation under these operational conditions.

RECOMMENDED ACTION	Proactive surface remediation & protective coatings
---------------------------	---
