DOCK PYLON EVALUATION REPORT

Comprehensive Material Assessment & Preservation Analysis

CLIENT INFORMATION	
Name	: (Redacted – Sample Document)
Address	: (Redacted – Sample Document)
Email	: (Redacted – Sample Document)
Phone	: (Redacted – Sample Document)
Evaluation Date	06/02/2026
Evaluator	Ed R.

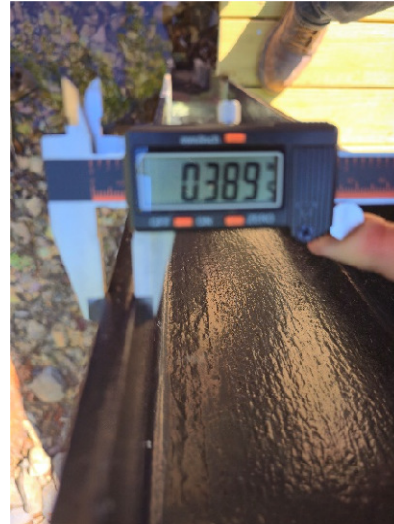
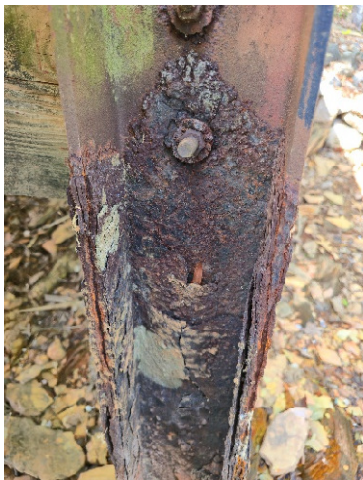
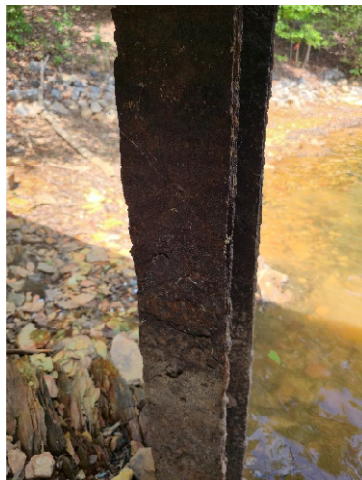
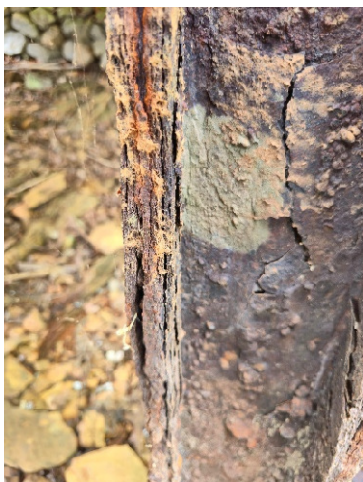
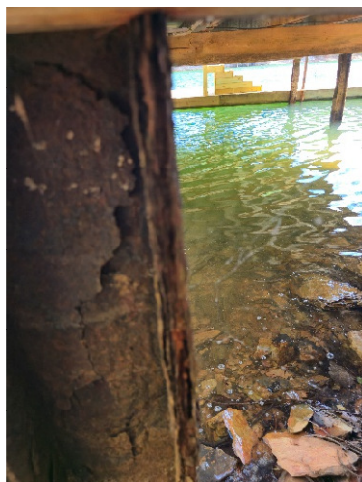
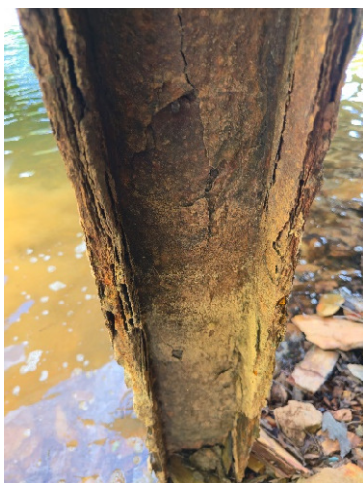
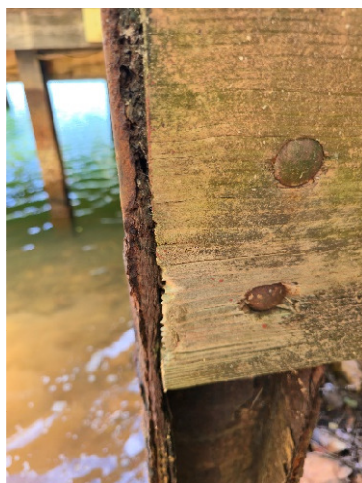
Metal Loss: 62% | Extreme Material Loss (Reconstruction Required)

MEASUREMENT	LEFT FLANGE	RIGHT FLANGE
Original Thickness	.381"	.389"
Neck / Splash Zone	.164"	.132"
Material Loss	62% — Extreme Material Loss (Reconstruction Required)

This pylon exhibits a documented 62% material loss. This represents a conservative baseline metric, as comprehensive mechanical descaling would be required to establish the full extent of the degradation, likely yielding a higher percentage. This component is one of two pylons supporting the main walkway girder. Because the localized material loss is so extensive, standard 24-inch heavy-duty reinforcement plates cannot be utilized, as there is insufficient remaining material on the upper portion of the pylon to securely anchor the hardware. Consequently, remediation via component replacement or reconstruction is recommended. Addressing this asset condition is critical to preventing total material depletion.

RECOMMENDED ACTION	Component reconstruction or replacement required
---------------------------	--

During reconstruction, it is recommended to install a web plate and replace the existing girder connection hardware. Following the completion of the reconstruction process, the entire pylon should receive a minimum of two coats of marine epoxy to encapsulate the component and mitigate subsequent atmospheric or water-line oxidation. Additionally, sacrificial anodes should be installed to provide ongoing galvanic protection for the newly reconstructed components.

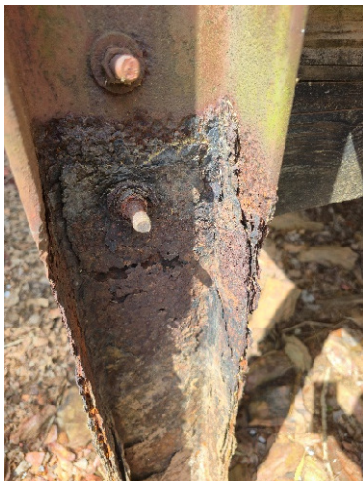
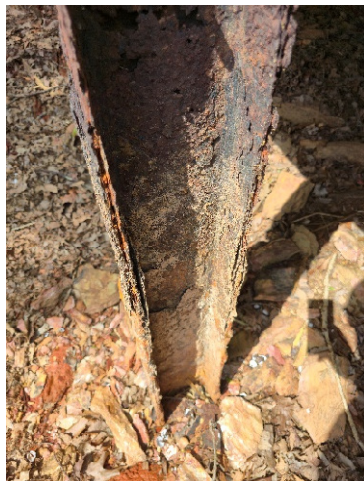
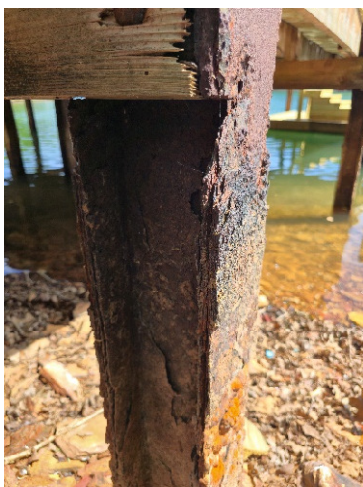
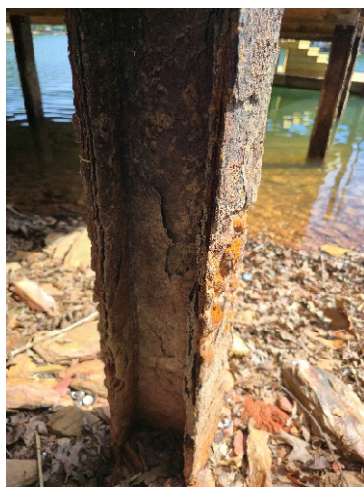
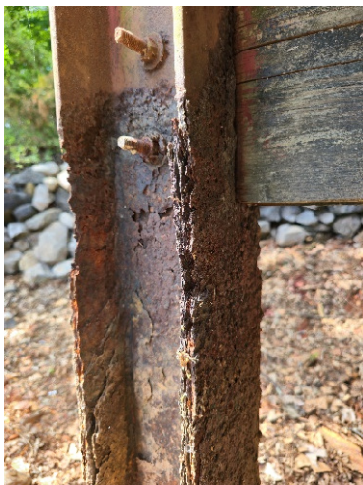
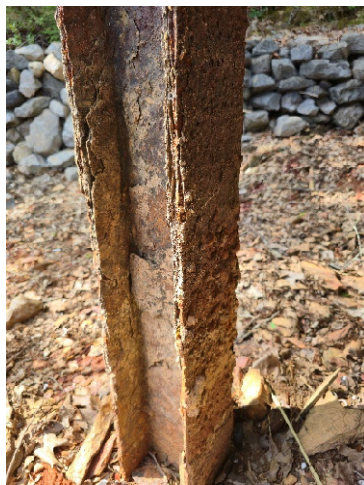
This pylon exhibits a documented 51% material loss. As this component pairs with the previously detailed pylon supporting the main walkway girder and shares a matching installation timeline, it exhibits a similar degradation pattern. Consequently, identical remediation protocols—including component replacement or reconstruction, hardware updates, web plate installation, marine epoxy encapsulation, and sacrificial anode implementation—are recommended for this asset.

RECOMMENDED ACTION	Component reconstruction or replacement required
---------------------------	--

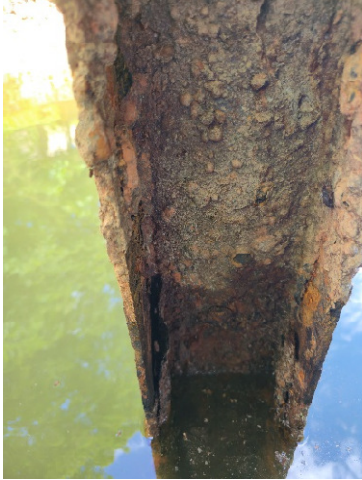
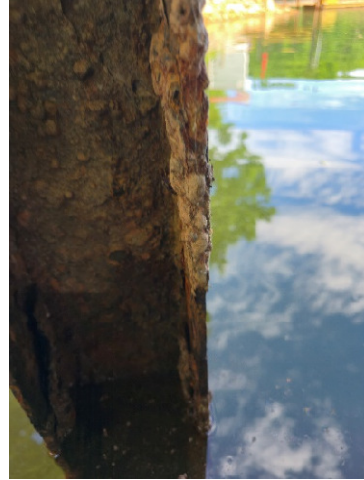
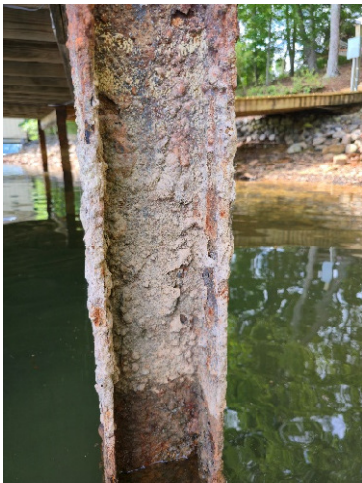
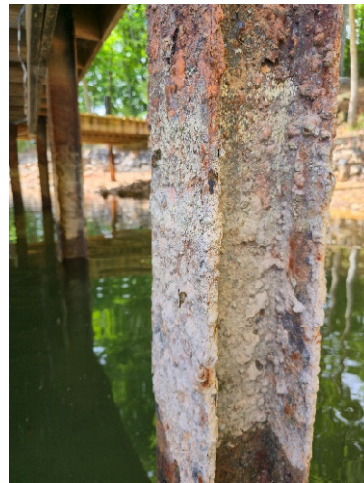
Metal Loss: 9% | Progressed Surface Corrosion (Heavy Scaling/Rust)

MEASUREMENT	LEFT FLANGE	RIGHT FLANGE
Original Thickness	.354"	.354"
Neck / Splash Zone	.307"	.335"
Material Loss	9% — Progressed Surface Corrosion (Heavy Scaling/Rust)

Severe, yet superficial, metal scaling is evident across the entire pylon, extending from the water line to the underside of the dock. While the overall average material loss remains low, localized measurements vary between the two flanges: one flange exhibits a 5% loss, while the opposing flange shows a 13% loss. Although the current average metric is within manageable parameters, it is critical to note that the localized degradation on the heavily affected flange is approaching the threshold of accelerated material thinning.

RECOMMENDED ACTION	Proactive surface remediation & protective coatings
---------------------------	---

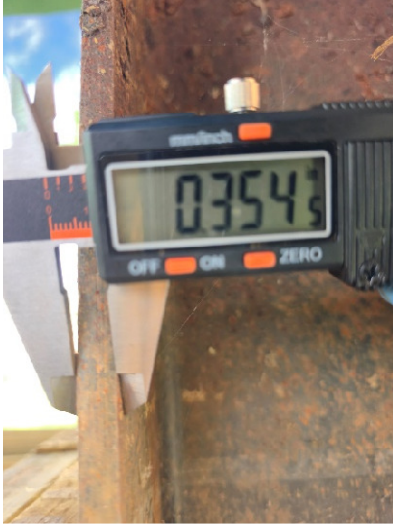
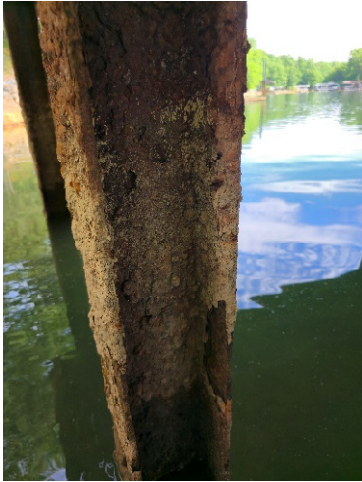
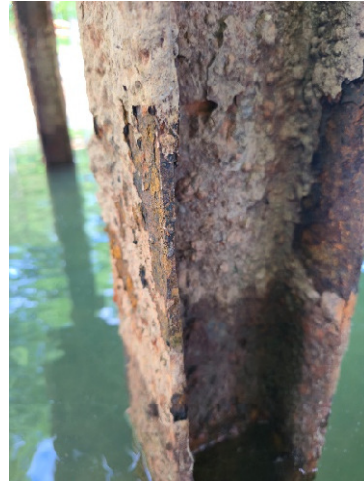
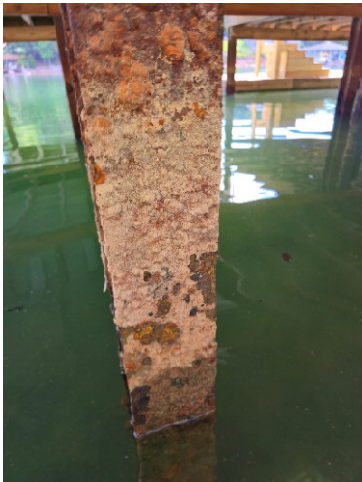
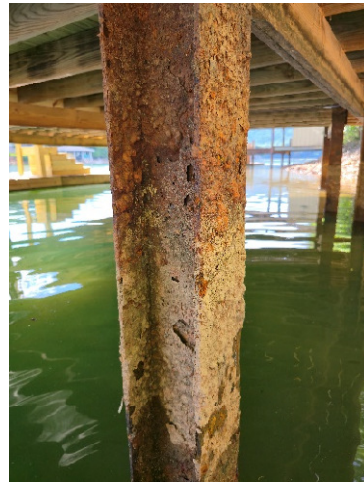
Metal Loss: 12% | Progressed Surface Corrosion (Heavy Scaling/Rust)

MEASUREMENT	LEFT FLANGE	RIGHT FLANGE
Original Thickness	.354"	.333"
Neck / Splash Zone	.302"	.301"
Material Loss	12% — Progressed Surface Corrosion (Heavy Scaling/Rust)

Severe, yet superficial, metal scaling is evident across the entire pylon, extending from the water line to the underside of the dock. While the overall average material loss remains low, localized measurements vary between the two flanges: one flange exhibits a 10% loss, while the opposing flange shows a 15% loss. Although the current average metric is within manageable parameters, it is critical to note that the localized degradation on the heavily affected flange is at the threshold of accelerated material thinning.

RECOMMENDED ACTION	Proactive surface remediation & protective coatings
---------------------------	---

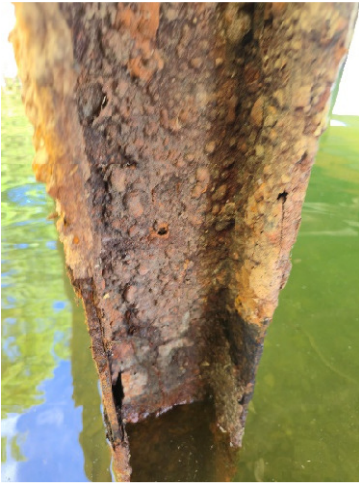
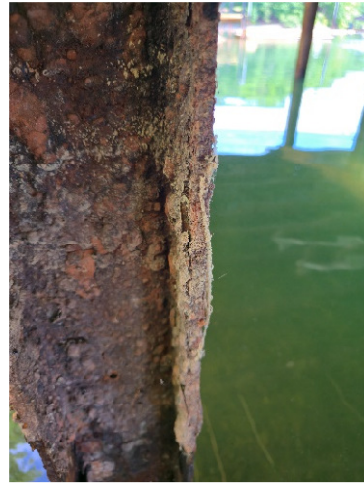
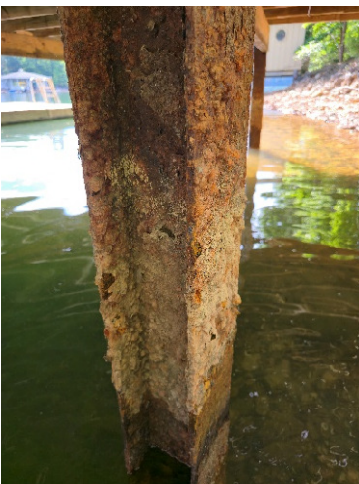
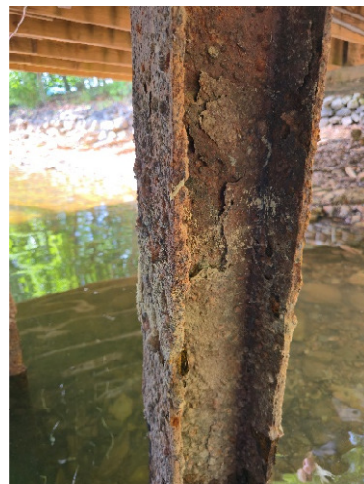
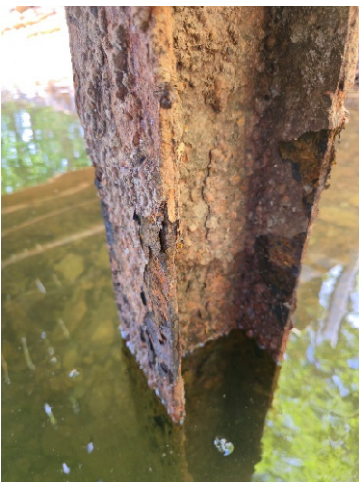
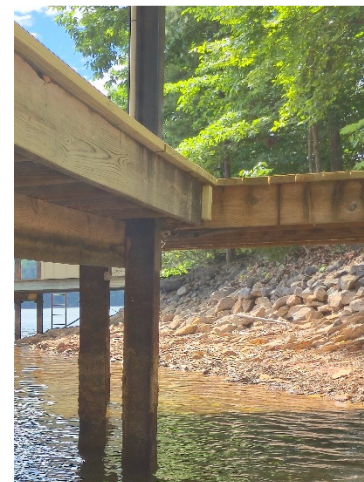
Metal Loss: 13% | Progressed Surface Corrosion (Heavy Scaling/Rust)

MEASUREMENT	LEFT FLANGE	RIGHT FLANGE
Original Thickness	.339"	.333"
Neck / Splash Zone	.296"	.292"
Material Loss	13% — Progressed Surface Corrosion (Heavy Scaling/Rust)

Severe, yet superficial, metal scaling is evident across the entire pylon, extending from the water line to the underside of the dock. While the overall average material loss currently remains low, at 13% it is approaching the threshold of accelerated material thinning.

RECOMMENDED ACTION	Proactive surface remediation & protective coatings
---------------------------	---

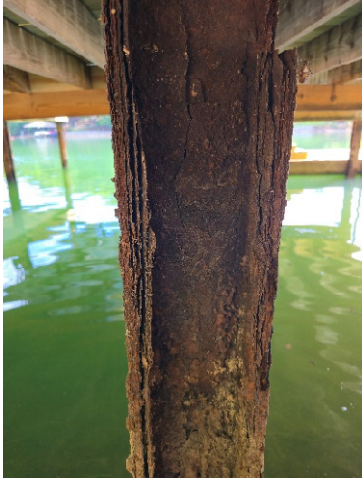
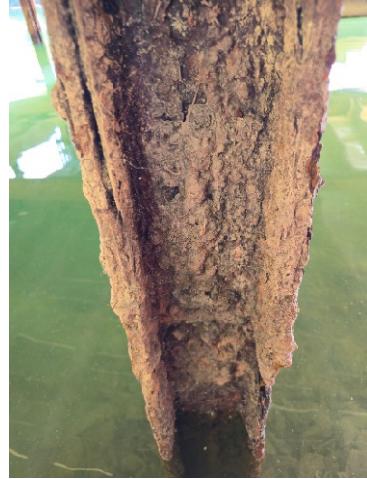
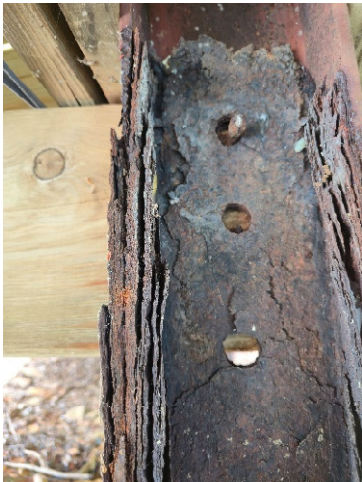
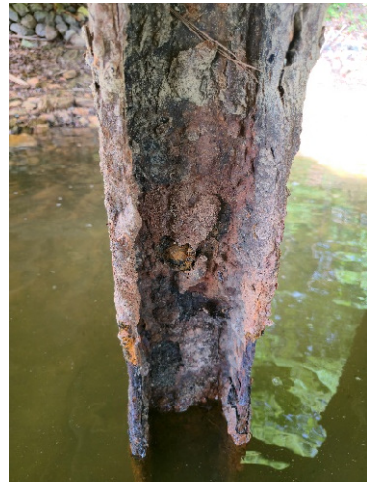
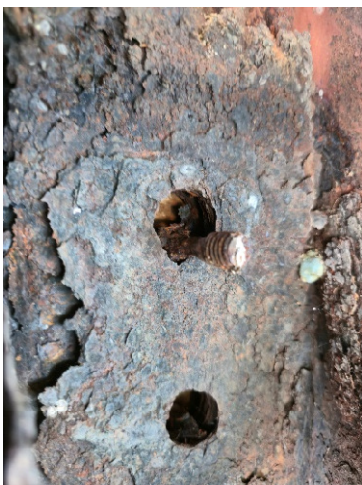
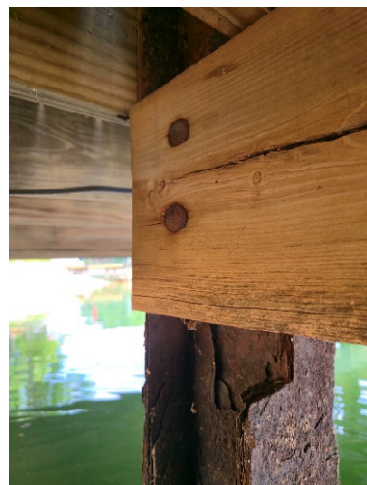
This pylon exhibits a documented 42% material loss. This represents a conservative baseline metric, as comprehensive mechanical descaling would be required to establish the full extent of the degradation, likely yielding a higher percentage. This component is one of two pylons supporting one of the main dock girders. Because the localized material loss is so extensive,

standard 24-inch heavy-duty reinforcement plates cannot be utilized, as there is insufficient remaining material on the upper portion of the pylon to securely anchor the hardware. Consequently, remediation via component replacement or reconstruction is recommended. Addressing this asset condition is critical to preventing total material depletion.

In this specific scenario, standard overall material loss percentages do not accurately reflect the severity of the asset condition, as the upper termination zone of the pylon exhibits approximately 90% total material depletion. Immediate remediation via component replacement or reconstruction is recommended to address this localized connection failure point.

RECOMMENDED ACTION	Reinforcement plating needed. Reconstruction recommended
---------------------------	--

During reconstruction, it is recommended to install a web plate and replace the existing girder connection hardware. Following the completion of the reconstruction process, the entire pylon should receive a minimum of two coats of marine epoxy to encapsulate the component and mitigate subsequent atmospheric or water-line oxidation. Additionally, sacrificial anodes should be installed to provide ongoing galvanic protection for the newly reconstructed components.

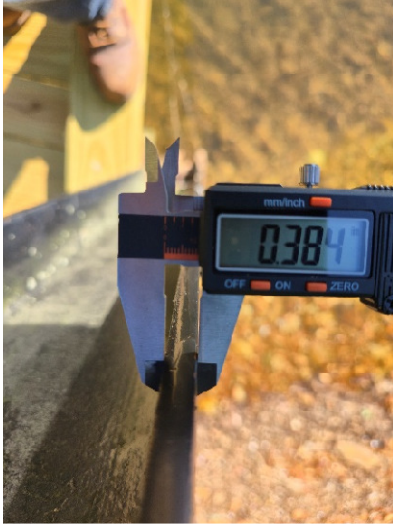
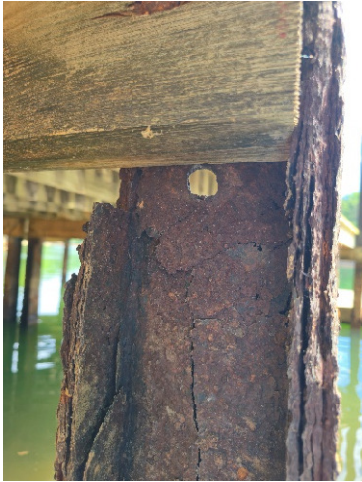
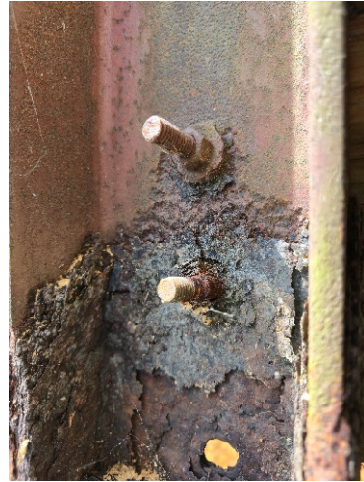
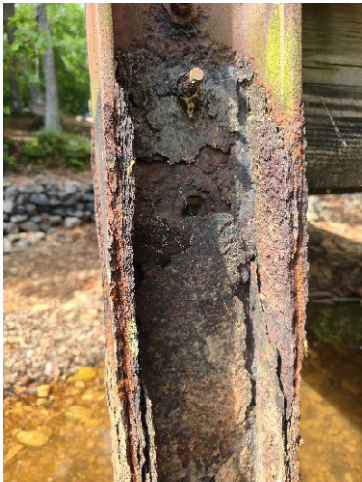
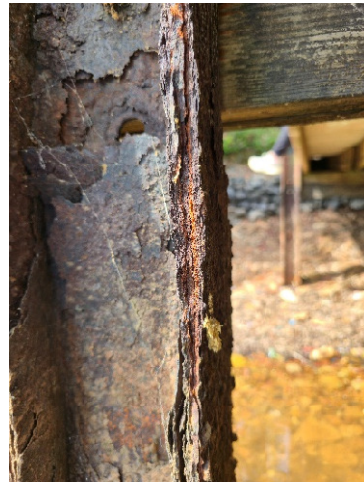
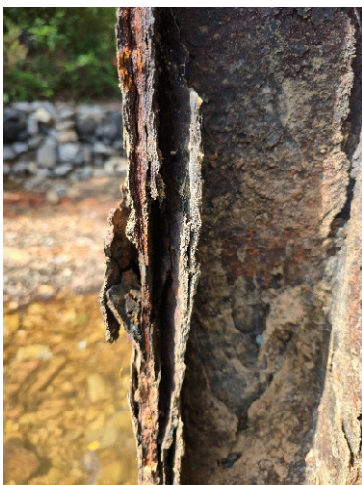
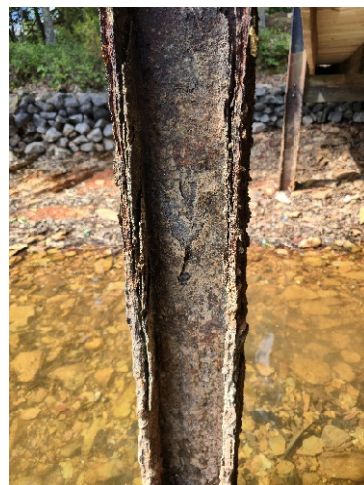
Metal Loss: 45% | Advanced Section Thinning (Plating Needed)

MEASUREMENT	LEFT FLANGE	RIGHT FLANGE
Original Thickness	.384"	.373"
Neck / Splash Zone	.191"	.224"
Material Loss	45% — Advanced Section Thinning (Plating Needed)

This pylon exhibits a documented 45% material loss. Measurement was made without scraping for safety purposes and to minimize any disruption to this fragile asset. This represents a conservative baseline metric, as comprehensive mechanical descaling would be required to establish the full extent of the degradation, likely yielding a higher percentage. This component

is one of two pylons supporting one of the main dock girders. Because the localized material loss is so extensive, standard 24-inch heavy-duty reinforcement plates cannot be utilized, as there is insufficient remaining material on the upper portion of the pylon to securely anchor the hardware. Consequently, remediation via component replacement or reconstruction is recommended. Addressing this asset condition is critical to preventing total material depletion.

Visual documentation of the upper pylon zone reveals a complete absence of flange support infrastructure. The interface relies entirely on two existing fasteners attached to the heavily degraded pylon. Of these two fasteners, one appears entirely encapsulated by corrosion within the girder and beam interface. Physical deformation of the upper fastener, which is visibly bent downward, indicates it is independently supporting the physical connection.

In this specific scenario, standard overall material loss percentages do not accurately reflect the severity of the asset condition, as the upper termination zone of the pylon exhibits 100% total material depletion of the original supporting flange structure. Immediate remediation via component replacement or reconstruction is recommended to address this localized connection failure point.

RECOMMENDED ACTION	Reinforcement plating needed. Reconstruction recommended
---------------------------	--

During reconstruction, it is recommended to install a web plate and replace the existing girder connection hardware. Following the completion of the reconstruction process, the entire pylon should receive a minimum of two coats of marine epoxy to encapsulate the component and mitigate subsequent atmospheric or water-line oxidation. Additionally, sacrificial anodes should be installed to provide ongoing galvanic protection for the newly reconstructed components.

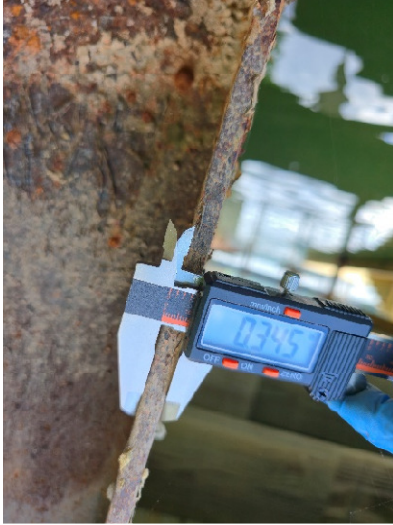
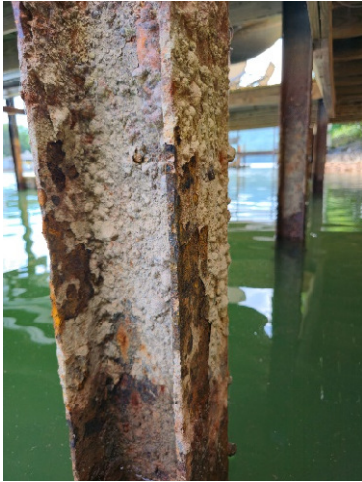
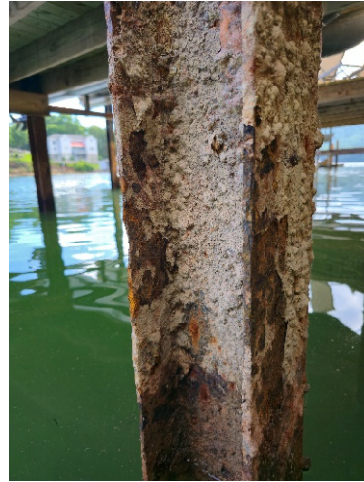
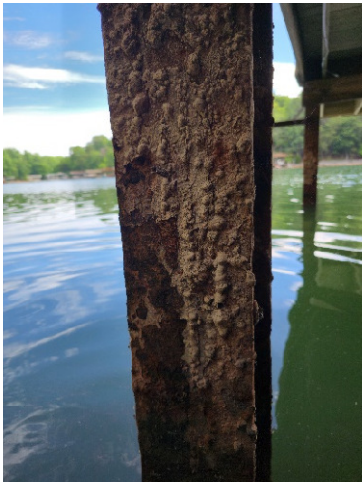
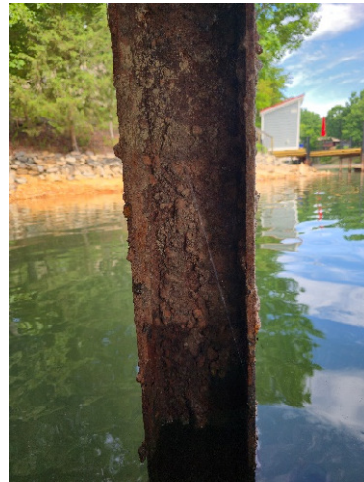
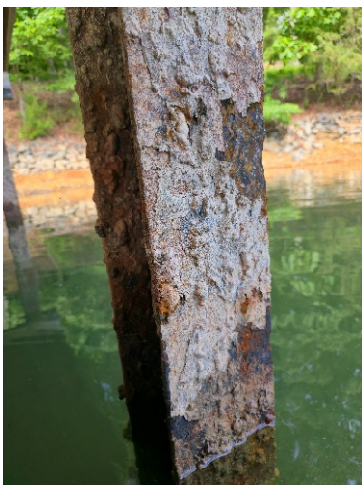
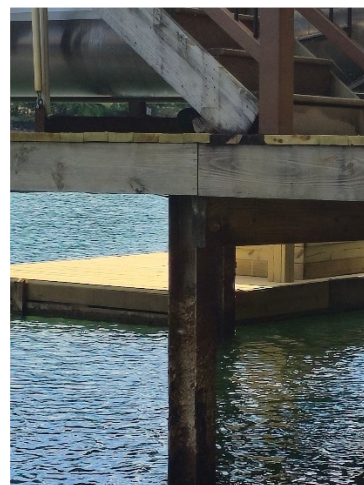
Metal Loss: 8% | Surface Corrosion (Heavy Scaling/Rust)

MEASUREMENT	LEFT FLANGE	RIGHT FLANGE
Original Thickness	.345"	.368"
Neck / Splash Zone	.310"	.348"
Material Loss	8% — Surface Corrosion (Heavy Scaling/Rust)

Severe, yet superficial, metal scaling is evident across the entire pylon, extending from the water line to the underside of the dock. While the overall average material loss remains low, localized measurements vary between the two flanges: one flange exhibits a 5% loss, while the opposing flange shows a 10% loss. Although the current average metric is within manageable

parameters, it is critical to note that the localized degradation on the heavily affected flange represents twice the material loss of the opposing flange.

RECOMMENDED ACTION	Proactive surface remediation & protective coatings
---------------------------	---

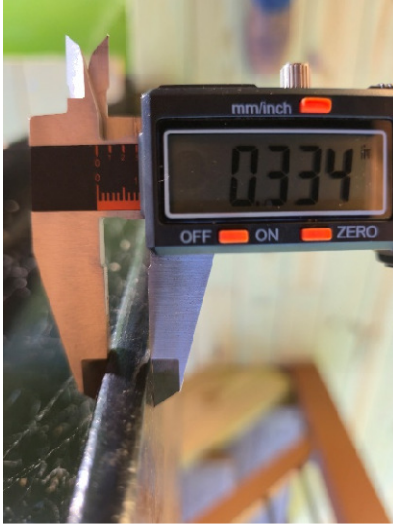
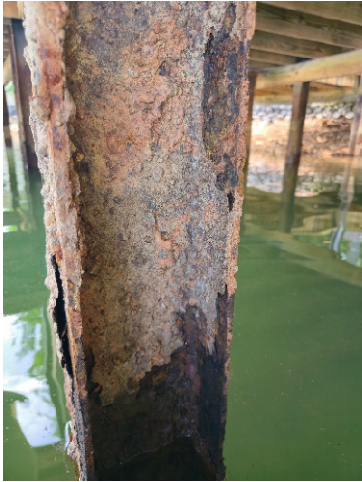
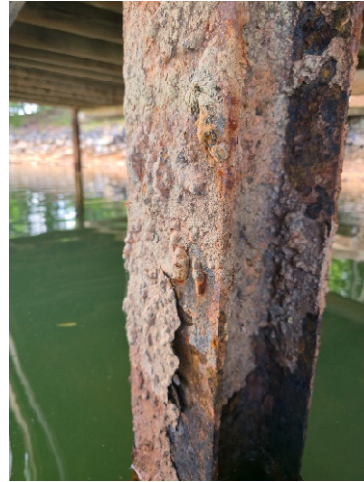
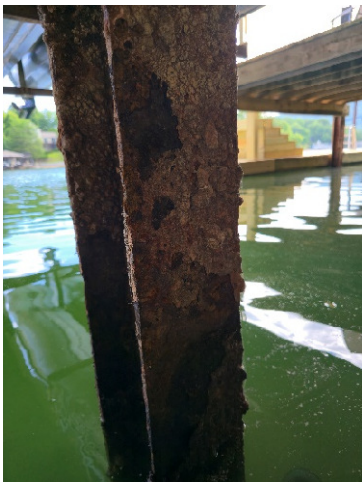
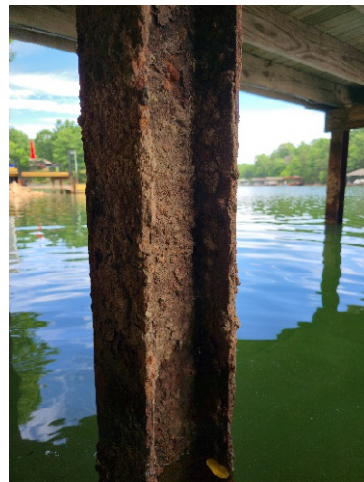
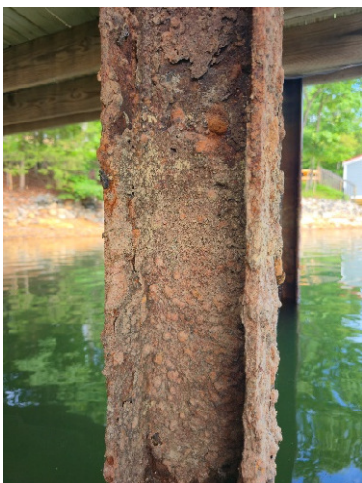
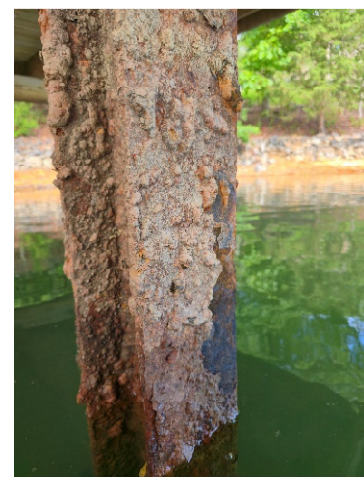
Metal Loss: 16% | Accelerated Section Thinning (Severe Scaling)

MEASUREMENT	LEFT FLANGE	RIGHT FLANGE
Original Thickness	.334"	.352"
Neck / Splash Zone	.287"	.287"
Material Loss	16% — Accelerated Section Thinning

Although localized profile narrowing (necking) is the primary observation, active rust scaling is present across the entire pylon surface, extending continuously from the water line to the underside of the dock structure. Measuring at approximately 16% material loss within the splash zone, this component has progressed beyond baseline environmental weathering.

RECOMMENDED ACTION	Proactive surface remediation & protective coatings
---------------------------	---

Implementation of encapsulation protocols at this stage is recommended to arrest ongoing oxidation and mitigate subsequent material loss that would necessitate the future use of heavy-duty steel reinforcement plates.

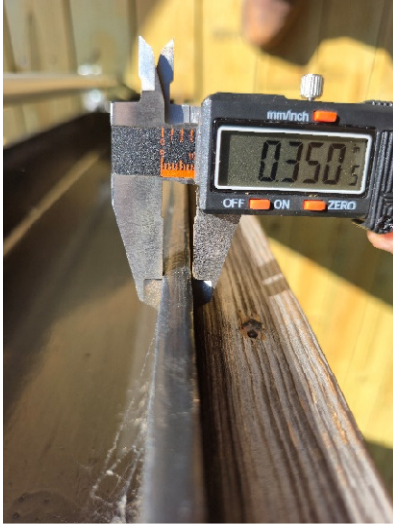
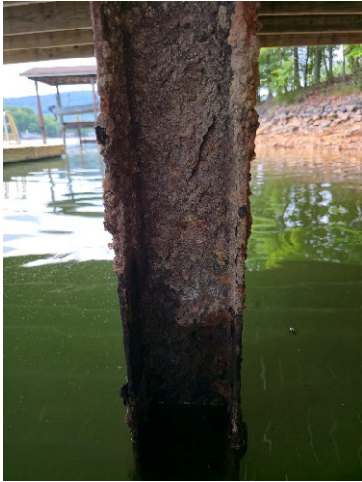
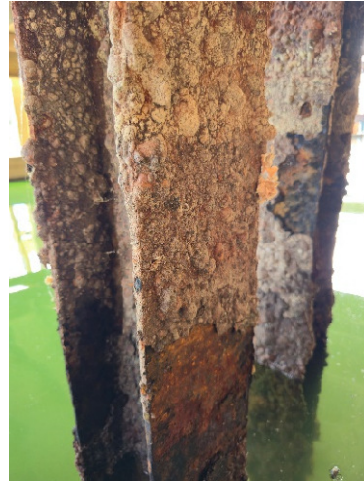
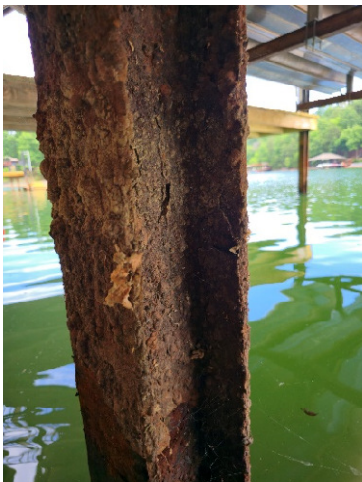
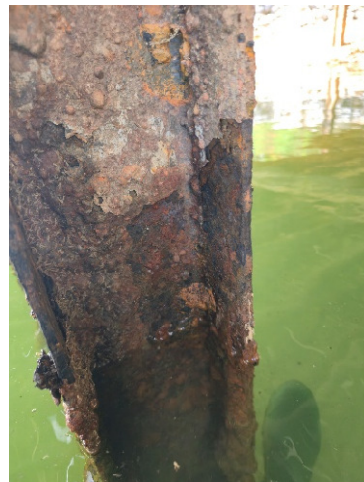
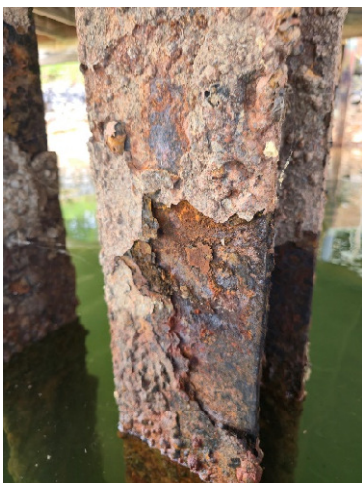
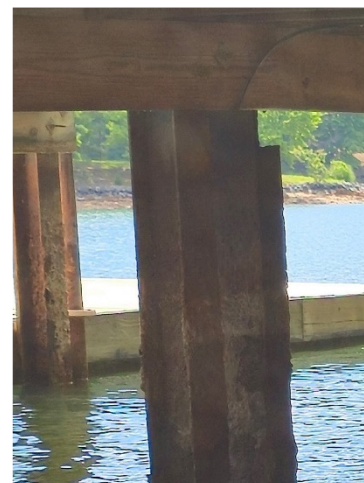
Metal Loss: 15% | Progressed Surface Corrosion (Heavy Scaling/Rust)

MEASUREMENT	LEFT FLANGE	RIGHT FLANGE
Original Thickness	.350"	.328"
Neck / Splash Zone	.277"	.297"
Material Loss	15% — Progressed Surface Corrosion (Heavy Scaling/Rust)

Severe, yet superficial, metal scaling is evident across the entire pylon, extending from the water line to the underside of the dock. While the overall average material loss currently remains low, at 15% it is approaching the threshold of accelerated material thinning

RECOMMENDED ACTION	Proactive surface remediation & protective coatings
---------------------------	---

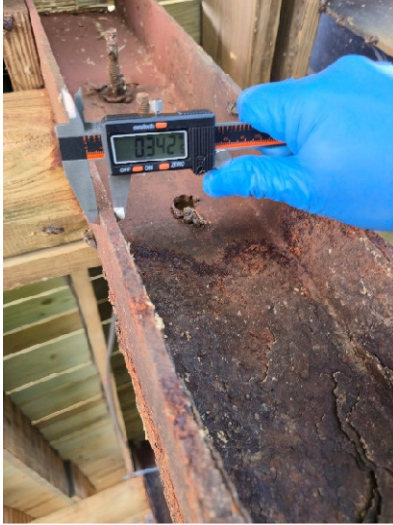
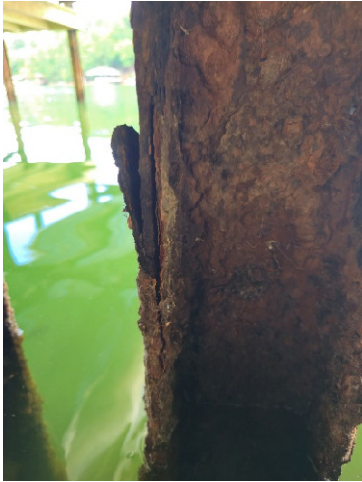
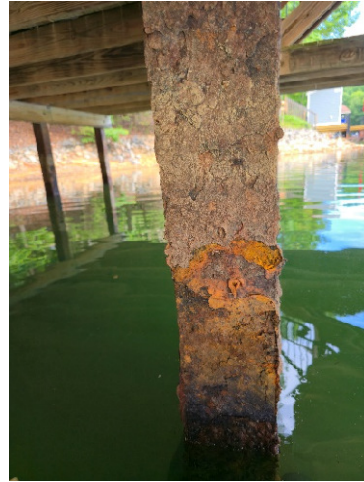
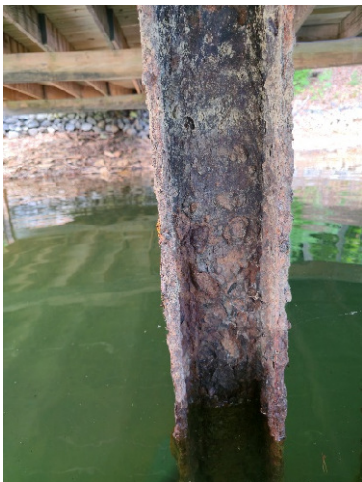
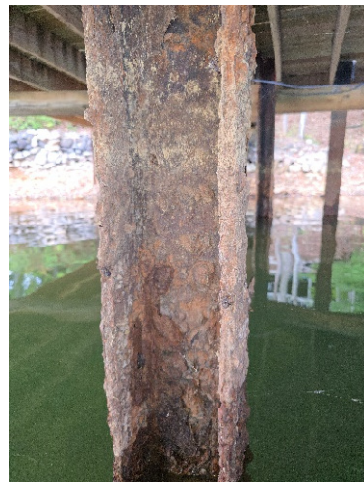
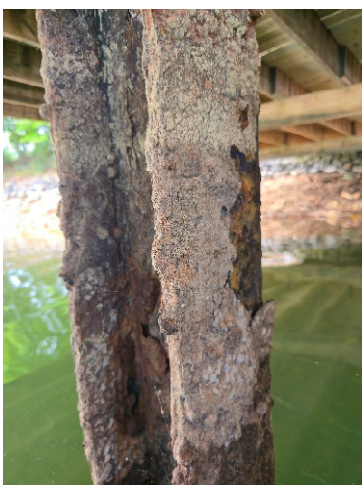
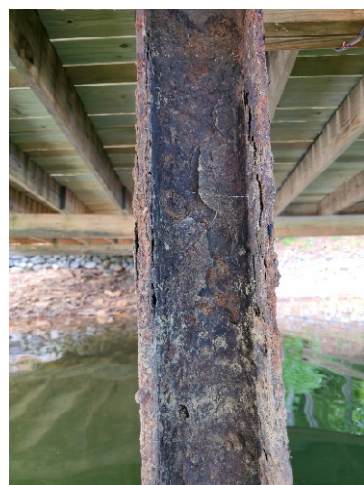
Metal Loss: 36% | Advanced Section Thinning (Plating Needed)

MEASUREMENT	LEFT FLANGE	RIGHT FLANGE
Original Thickness	.342"	.347"
Neck / Splash Zone	.210"	.231"
Material Loss	36% — Advanced Section Thinning (Plating Needed)

This pylon measures at 36% metal loss, indicating advanced section thinning. Based on these measurements, we recommend the installation of heavy-duty reinforcement plating. Mechanical descaling is required to fully determine the exact condition of the underlying steel.

RECOMMENDED ACTION	Reinforcement plating — reconstruction recommended
---------------------------	--

At this tier of material degradation, the application of reinforcement plates is recommended as a standard preventative measure.

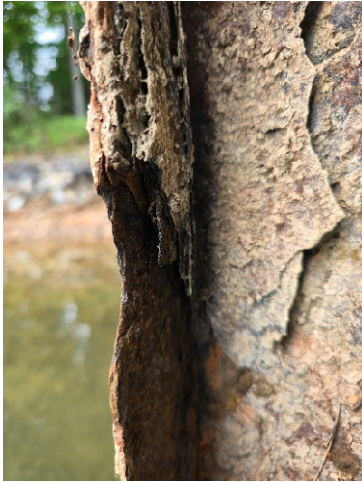
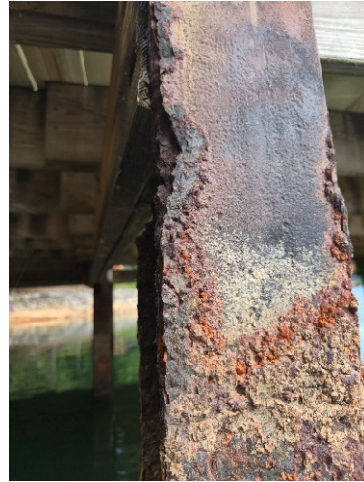
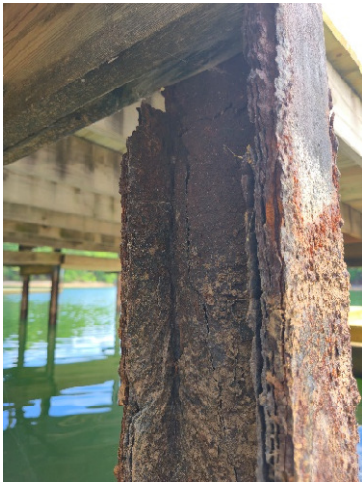
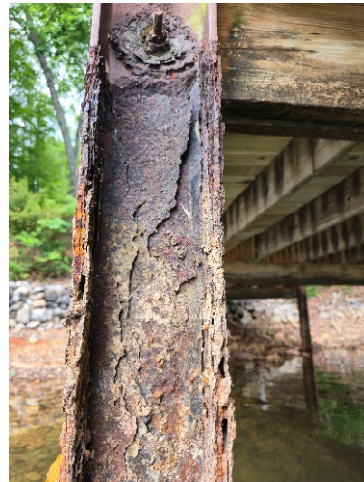
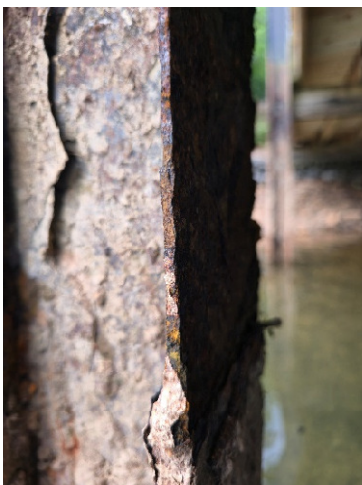
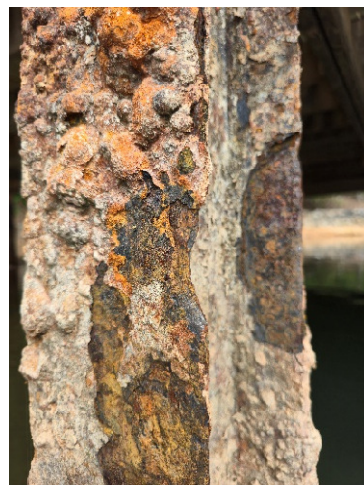
This pylon exhibits a documented 36% material loss. Measurement was made without scraping for safety purposes and to minimize any disruption to this fragile asset. This represents a conservative baseline metric, as comprehensive mechanical descaling would be required to establish the full extent of the degradation, likely yielding a higher percentage. This component

is a primary support for one of the main dock girders. Because the localized material loss is so extensive, standard 24-inch heavy-duty reinforcement plates cannot be utilized, as there is insufficient remaining material on the upper portion of the pylon to securely anchor the hardware. Consequently, remediation via component replacement or reconstruction is recommended. Addressing this asset condition is critical to preventing total material depletion.

⚠ CRITICAL CONDITION NOTE

Visual documentation of the upper pylon zone reveals a complete absence of flange support infrastructure. The interface relies entirely on two existing fasteners attached to the heavily degraded pylon. Of these two fasteners, one appears entirely encapsulated by corrosion within the girder and beam interface, this leaves the single upper fastener to independently support the physical connection.

In this specific scenario, standard overall material loss percentages do not accurately reflect the severity of the asset condition, as the upper termination zone of the pylon exhibits 100% total material depletion of the original supporting flange structure. Immediate remediation via component replacement or reconstruction is recommended to address this localized connection failure point.

RECOMMENDED ACTION	Reinforcement plating — reconstruction recommended
---------------------------	--

During reconstruction, it is recommended to install a web plate and replace the existing girder connection hardware. Following the completion of the reconstruction process, the entire pylon should receive a minimum of two coats of marine epoxy to encapsulate the component and mitigate subsequent atmospheric or water-line oxidation. Additionally, sacrificial anodes should be installed to provide ongoing galvanic protection for the newly reconstructed components.

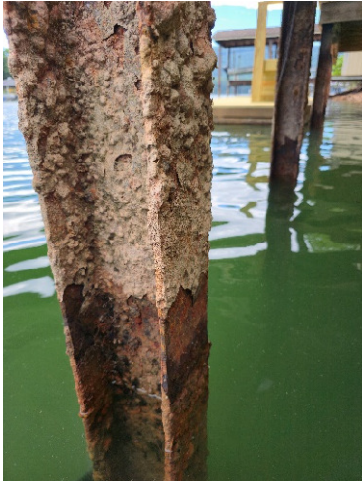
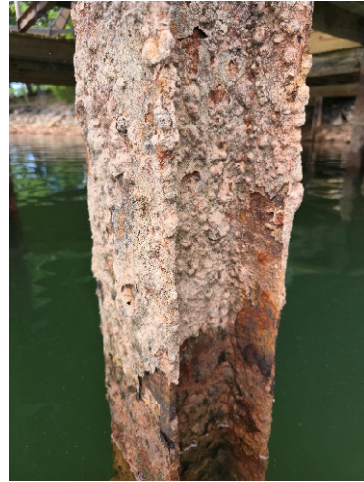
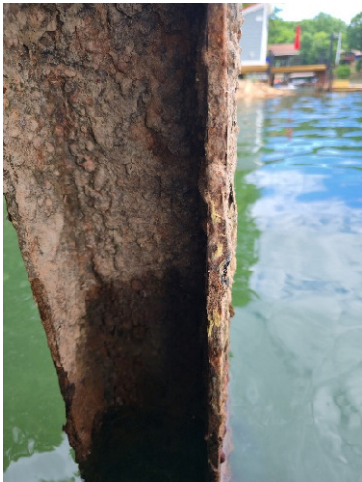
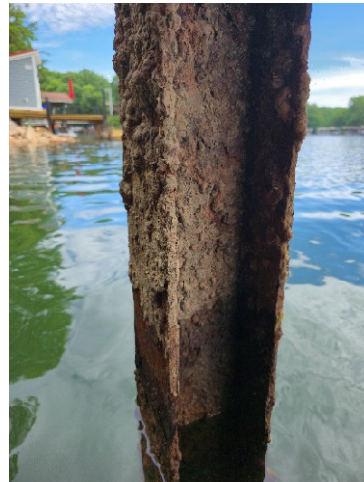
Metal Loss: 5% | Surface Corrosion (Heavy Scaling/Rust)

MEASUREMENT	LEFT FLANGE	RIGHT FLANGE
Original Thickness	.351"	.359"
Neck / Splash Zone	.331"	.341"
Material Loss	5% — Surface Corrosion (Heavy Scaling/Rust)

Although the surface scaling appears heavy, measurements confirm metal loss is minimal. Active rust scaling is present across the entire pylon surface, extending continuously from the water line to the underside of the dock structure. Because this component serves as a direct foundational path for an active, multi-level upper deck assembly, maintaining its original steel thickness profile is a high priority. Consequently, proactive surface remediation and protective coatings are recommended at this stage to preserve the material profile and mitigate long-term oxidation under these operational conditions.

RECOMMENDED ACTION	Proactive surface remediation & protective coatings
---------------------------	---

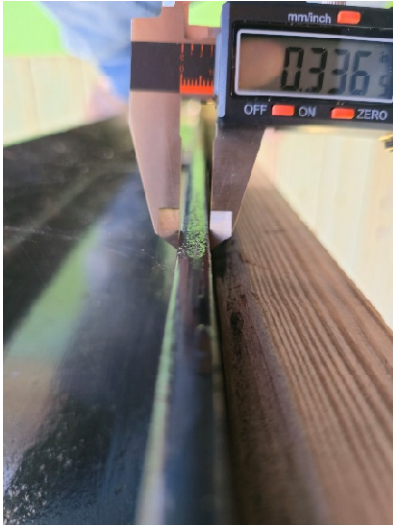
Measurement Readings

Metal Loss: 7% | Surface Corrosion (Heavy Scaling/Rust)

MEASUREMENT	LEFT FLANGE	RIGHT FLANGE
Original Thickness	.336"	.349"
Neck / Splash Zone	.314"	.321"
Material Loss	7% — Surface Corrosion (Heavy Scaling/Rust)

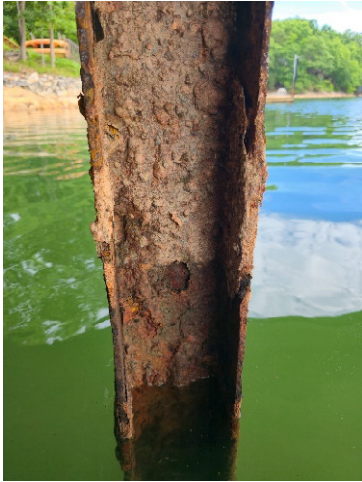
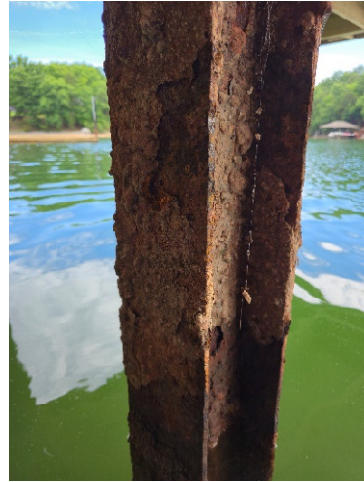
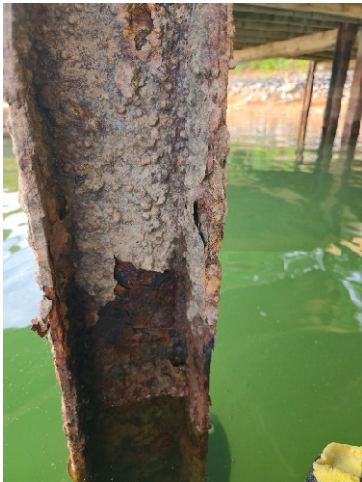
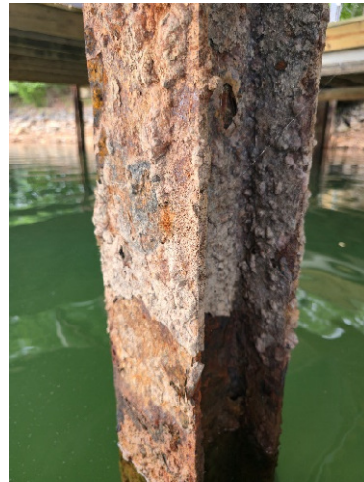
Although the surface scaling appears heavy, measurements confirm metal loss is minimal. Active rust scaling is present across the entire pylon surface, extending continuously from the water line to the underside of the dock structure. Because this component serves as a direct foundational path for an active, multi-level upper deck assembly, maintaining its original steel thickness profile is a high priority. Consequently, proactive surface remediation and protective coatings are recommended at this stage to preserve the material profile and mitigate long-term oxidation under these operational conditions.

RECOMMENDED ACTION	Proactive surface remediation & protective coatings
---------------------------	---

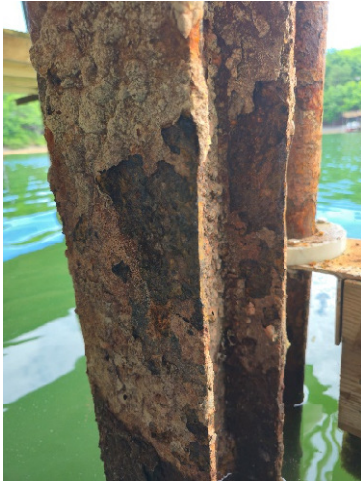
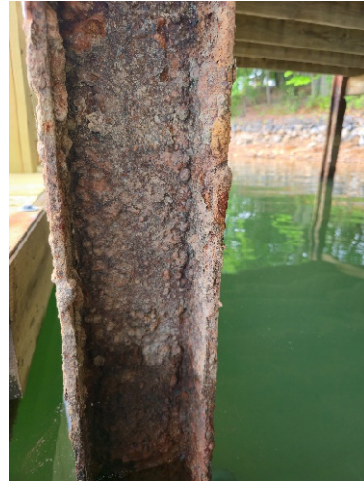
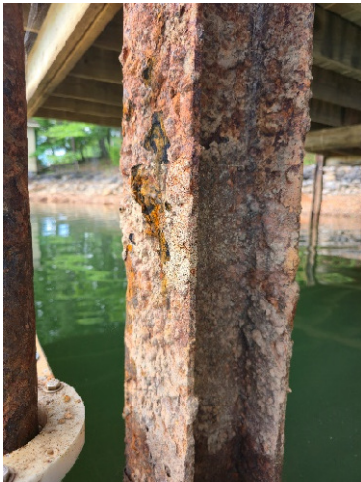
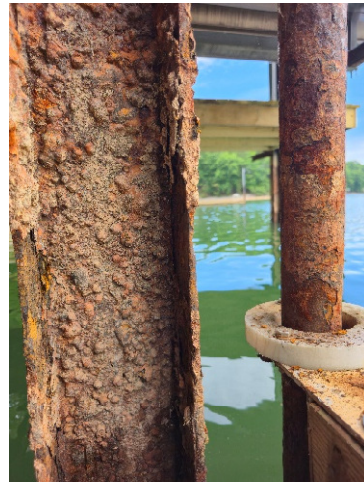
Metal Loss: 9% | Surface Corrosion (Heavy Scaling/Rust)

MEASUREMENT	LEFT FLANGE	RIGHT FLANGE
Original Thickness	.335"	.356"
Neck / Splash Zone	.307"	.325"
Material Loss	9% — Surface Corrosion (Heavy Scaling/Rust)

Although the surface scaling appears heavy, measurements confirm that overall material loss remains minimal. Active rust scaling is present across the entire pylon surface, extending continuously from the water line to the underside of the dock structure. Because this component serves as a direct foundational path for an active, multi-level upper deck assembly, maintaining its original steel thickness profile is a high priority. Consequently, proactive surface remediation and protective coatings are recommended at this stage to preserve the material profile and mitigate long-term oxidation under these operational conditions. This component also supports one of the two guide poles for the floating dock. The guide pole exhibits surface oxidation; it is recommended to mechanically descale this hardware and apply a marine epoxy coating as a preventative maintenance measure.

RECOMMENDED ACTION	Proactive surface remediation & protective coatings
---------------------------	---

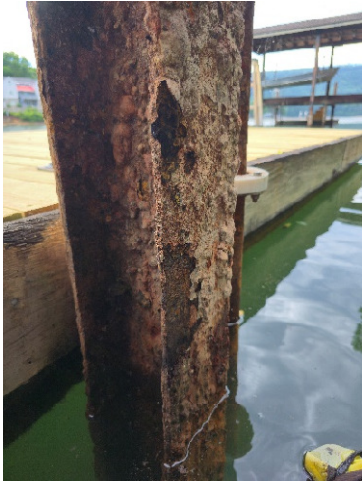
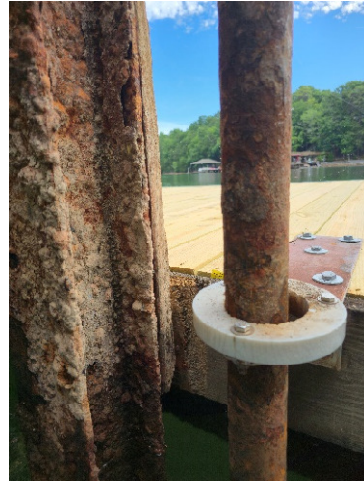
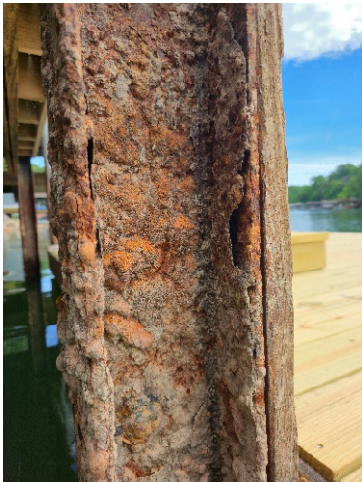
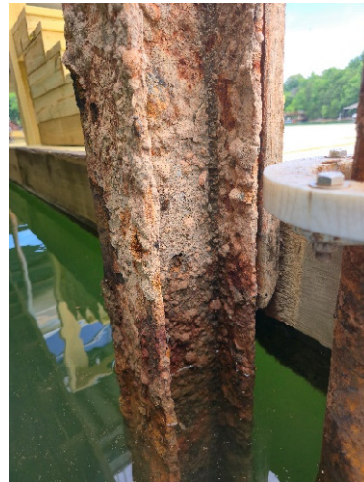
Metal Loss: 8% | Surface Corrosion (Heavy Scaling/Rust)

MEASUREMENT	LEFT FLANGE	RIGHT FLANGE
Original Thickness	.361"	.354"
Neck / Splash Zone	.333"	.324"
Material Loss	8% — Surface Corrosion (Heavy Scaling/Rust)

Although the surface scaling appears heavy, measurements confirm that overall material loss remains minimal. Active rust scaling is present across the entire pylon surface, extending continuously from the water line to the underside of the dock structure. This component supports one of the two guide poles for the floating dock. The guide pole exhibits surface oxidation; it is recommended to mechanically descale this hardware and apply a marine epoxy coating as a preventative maintenance measure.

Additionally, a wooden board is currently mounted lengthwise along the exterior of this pylon, seemingly installed to mitigate impact from the floating dock assembly during wave action. The timber board creates a moisture trap accelerating localized oxidation. Permanent removal of the timber board is recommended prior to epoxy encapsulation to preserve the underlying steel profile.

RECOMMENDED ACTION	Proactive surface remediation & protective coatings — remove timber board
---------------------------	---

To maintain impact mitigation without creating a destructive moisture trap against the steel, alternative non-porous materials or standalone marine bumper options that do not bond directly to the pylon surface should be explored to ensure long-term material stability.

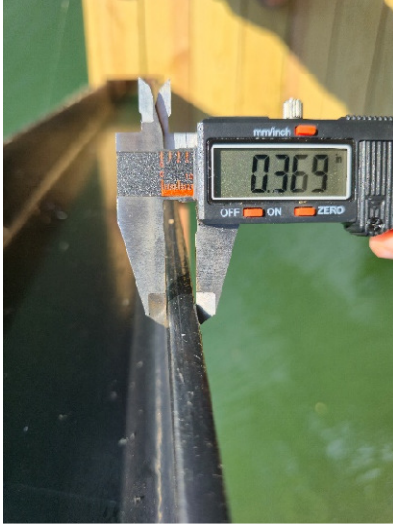
Measurement Readings

Metal Loss: 9% | Surface Corrosion (Heavy Scaling/Rust)

MEASUREMENT	LEFT FLANGE	RIGHT FLANGE
Original Thickness	.369"	.350"
Neck / Splash Zone	.339"	.318"
Material Loss	9% — Surface Corrosion (Heavy Scaling/Rust)
