DOCK PYLON EVALUATION REPORT

Comprehensive Material Assessment & Preservation Analysis

CLIENT INFORMATION	
Name	: (Redacted – Sample Document)
Address	: (Redacted – Sample Document)
Email	: (Redacted – Sample Document)
Phone	: (Redacted – Sample Document)
Evaluation Date	06/02/2026
Evaluator	Ed R.

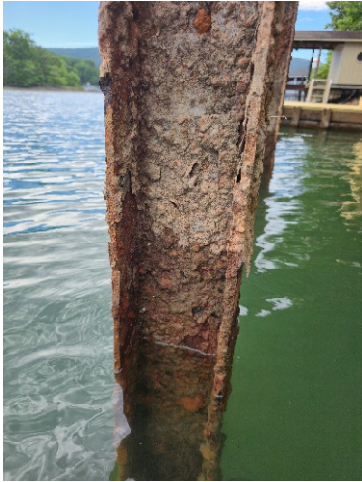
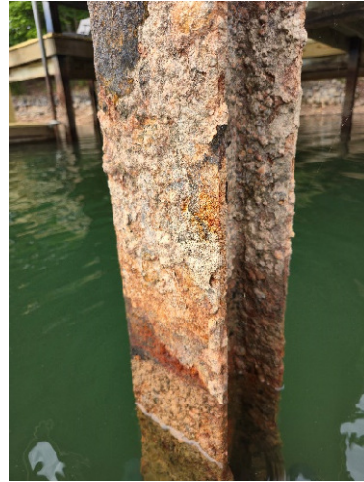
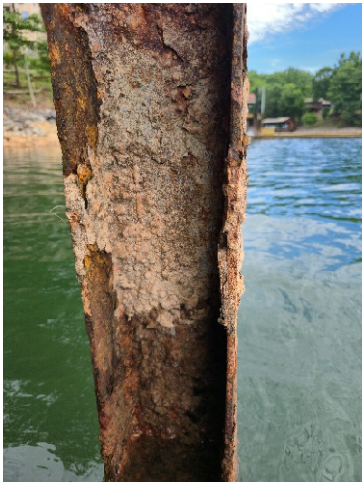
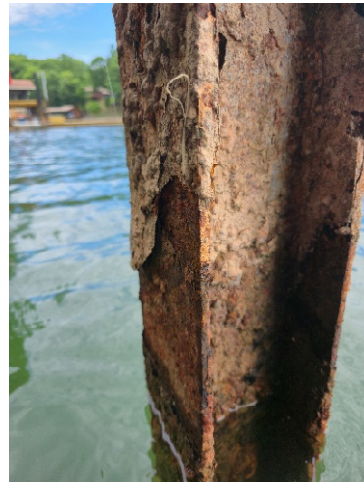
Although the surface scaling appears heavy, measurements confirm that overall material loss remains minimal. Active rust scaling is present across the entire pylon surface, extending continuously from the water line to the underside of the dock structure. Because this component serves as a direct foundational path for an active, multi-level upper deck assembly, maintaining its original steel thickness profile is a high priority. Consequently, proactive surface remediation and protective coatings are recommended at this stage to preserve the material profile and mitigate long-term oxidation under these operational conditions.

RECOMMENDED ACTION	Proactive surface remediation & protective coatings
---------------------------	---

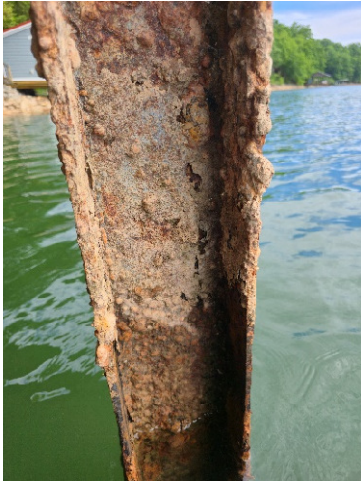
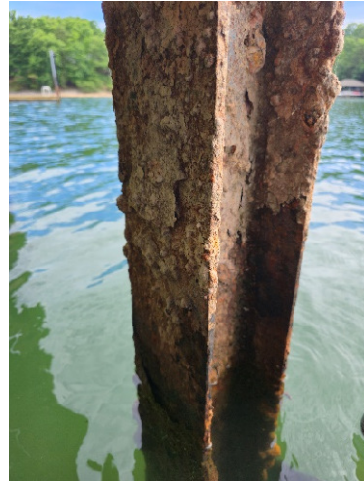
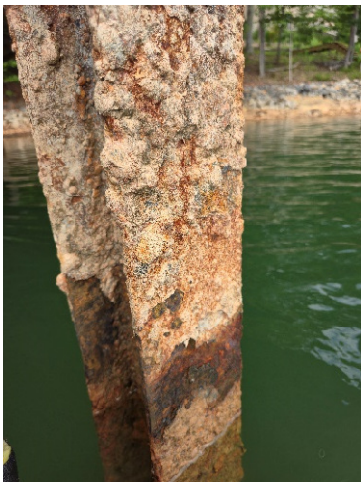
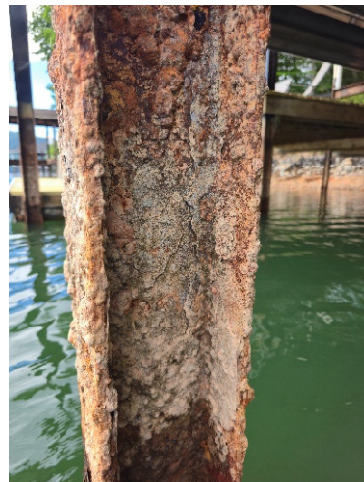
Metal Loss: 8% | Surface Corrosion (Heavy Scaling/Rust)

MEASUREMENT	LEFT FLANGE	RIGHT FLANGE
Original Thickness	.354"	.366"
Neck / Splash Zone	.326"	.338"
Material Loss	8% — Surface Corrosion (Heavy Scaling/Rust)

Although the surface scaling appears heavy, measurements confirm that overall material loss remains minimal. Active rust scaling is present across the entire pylon surface, extending continuously from the water line to the underside of the dock structure. Because this component serves as a direct foundational path for an active, multi-level upper deck assembly, maintaining its original steel thickness profile is a high priority. Consequently, proactive surface remediation and protective coatings are recommended at this stage to preserve the material profile and mitigate long-term oxidation under these operational conditions.

RECOMMENDED ACTION	Proactive surface remediation & protective coatings
---------------------------	---

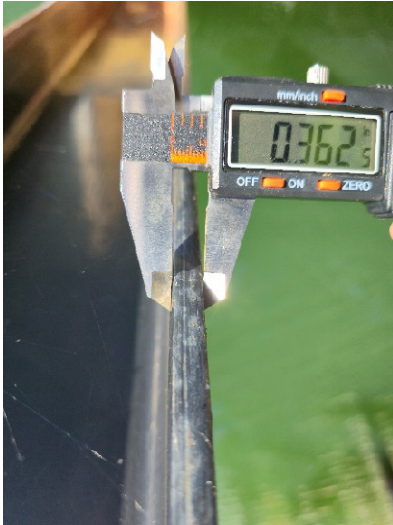
Measurement Readings

Metal Loss: 8% | Surface Corrosion (Heavy Scaling/Rust)

MEASUREMENT	LEFT FLANGE	RIGHT FLANGE
Original Thickness	.362"	.353"
Neck / Splash Zone	.322"	.338"
Material Loss	8% — Surface Corrosion (Heavy Scaling/Rust)

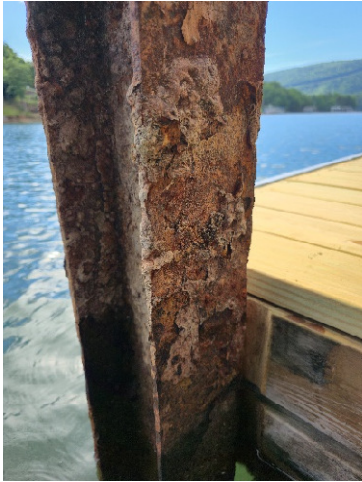
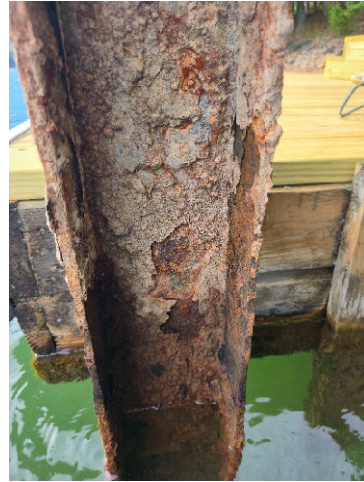
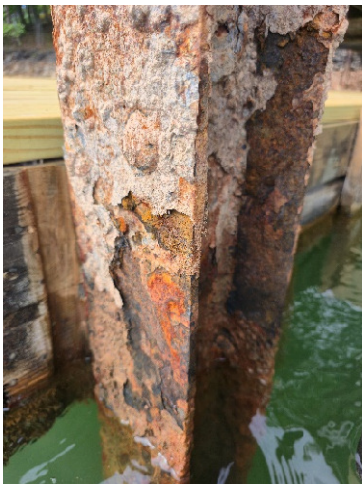
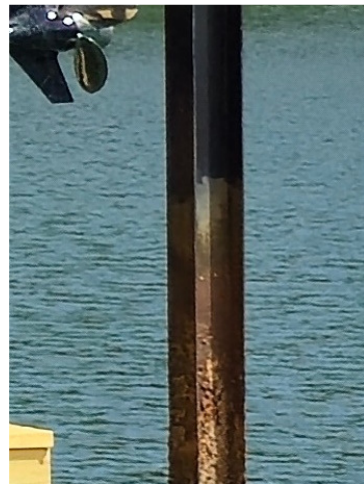
Although the surface scaling appears heavy, measurements confirm that overall material loss remains minimal, with active rust scaling limited primarily to the necking zone on the pylon. Localized measurements vary between the two flanges: one flange exhibits a 4% loss, while the opposing flange shows an 11% loss. Although the current average metric is within manageable parameters, the localized degradation on the heavily affected flange represents over twice the material loss of the opposing flange.

Because this component serves as a direct foundational path for an active, multi-level upper deck assembly, maintaining its original steel thickness profile is a high priority. Consequently, proactive surface remediation and protective coatings are recommended at this stage to preserve the material profile and mitigate long-term oxidation under these operational conditions.

RECOMMENDED ACTION	Proactive surface remediation & protective coatings
---------------------------	---
